**ROAD SECTOR DEVELOPMENT PROJECT (AF)**  
(IDA Credit Number- 4832-NP, IDA Grant Number- H629-NP)

**FINAL REPORT FOR EXTERNAL MONITORING OF ENVIRONMENTAL SAFEGAURD  
IMPLEMENTATION IN RSDP AF PROJECTS**

**(SM, CJ & KMJ Roads)**

**June, 2013**

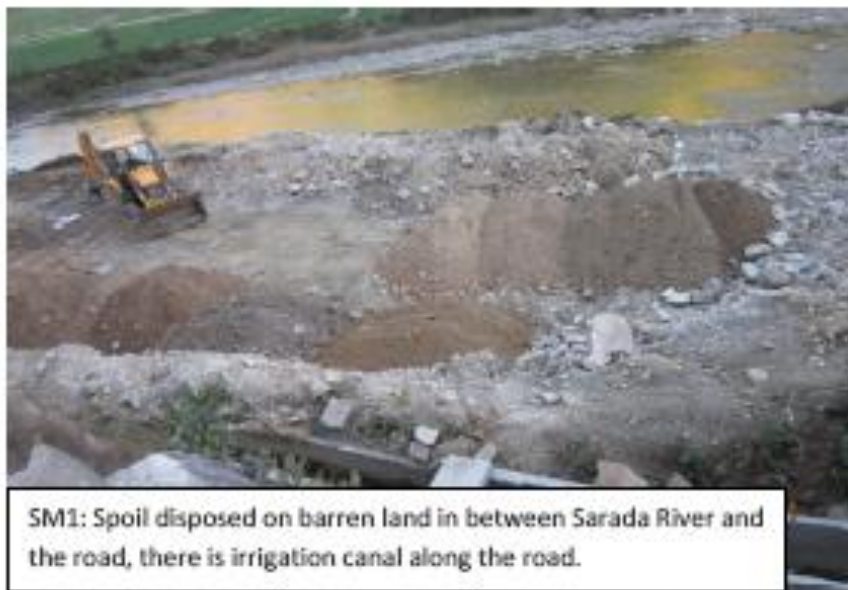
| 4A (52+650 – 75+500) | | | |
|---|---|---|---|
| 54+600 | Spoil disposal site | Spoil disposed on barren land in between Sarada river and the road, there is irrigation canal along the road, (photo: SM1) | Any blockage formed due to this activity should be cleared. The deposited spoil should be compacted after its use. Embankment should be constructed along the Sarada river in this section. |

SM1: Spoil disposed on barren land in between Sarada River and the road, there is irrigation canal along the road.

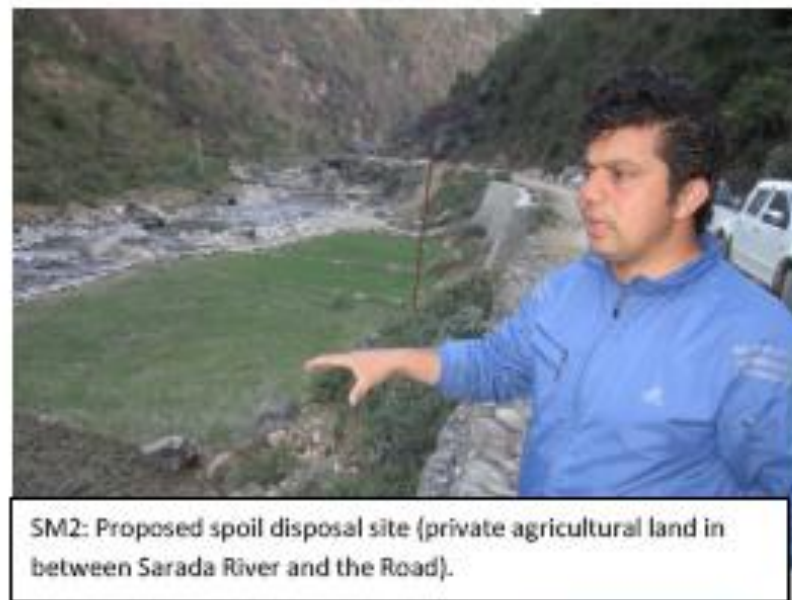
| 4A (52+650 – 75+500) | | | |
|---|---|---|---|
| 59+200 | Proposed disposal site | This site is between private agricultural land and Sarada River. There is also an irrigation canal in between road and the agricultural land. Activity can damage the fertility land. (photo:SM2) | Not very suitable site for this purpose as fertile arable land. |

SM2: Proposed spoil disposal site (private agricultural land in between Sarada River and the Road).

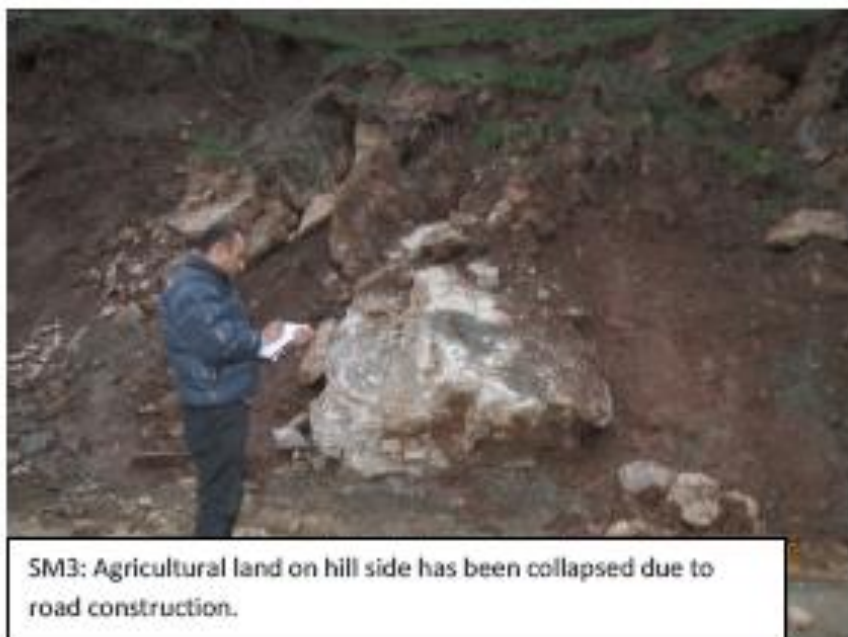
| 4A (52+650 – 75+500) | | | |
|---|---|---|---|
| 62+300<br>(near Dhor Chaur Bridge) | Damage on agricultural land | Agricultural land on hill side has collapsed due to road construction. (photo:SM3) | Breast wall construction should be constructed immediately to protect farmland towards hillside. Road safety sign needed |

SM3: Agricultural land on hill side has been collapsed due to road construction.

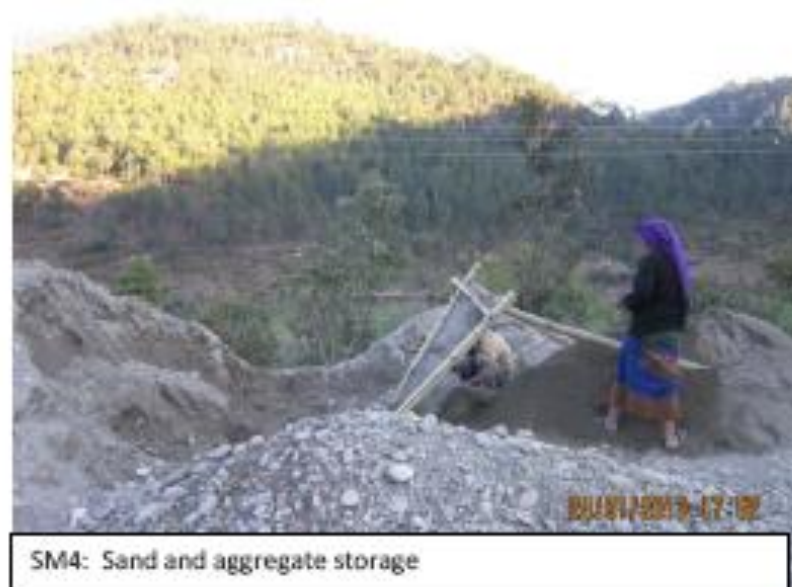
SM4: Sand and aggregate storage

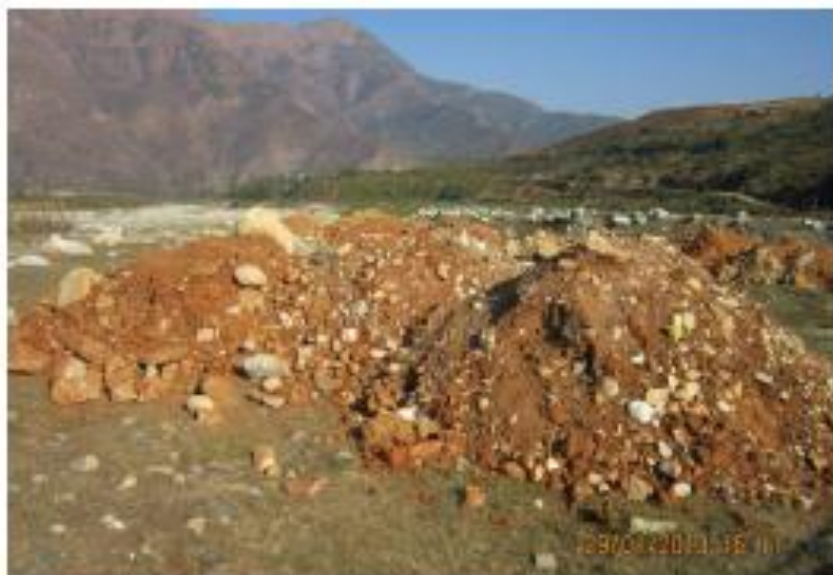
| <b>5A (26+00 - 46+400)</b> | | | |
|---|---|---|---|
| 51+300 (Goji river) | Spoil disposal | Heaps of spoil were deposited on the bank of Goji river. (photo:CJ3) | Those deposits must be compacted and gabion wall should be constructed toward the river. |

CJ3: Heaps of spoil deposited on the bank of Goji river

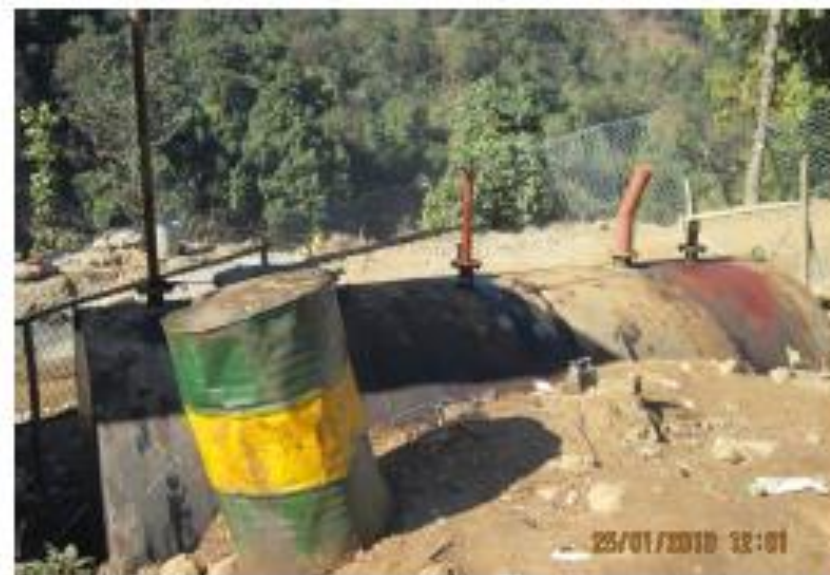
| 81+200 | Fuel storage/contractor camp | Fuel stored in underground metal tank. (photoCJ4) | No action needed. |

CJ4: Fuel stored in underground metal tank

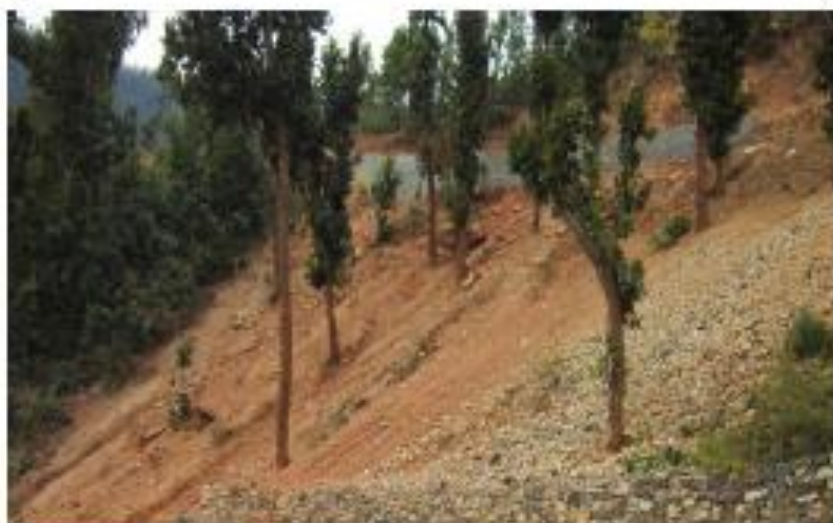
| 103+250 | Slope failure | Debris fallen from high above crossing the existing road at three different points. (photo:CJ5) | Proper drainage management + gabion wall + bioengineering |

CJ5: Debris fallen from high above crossing the existing road at three different points

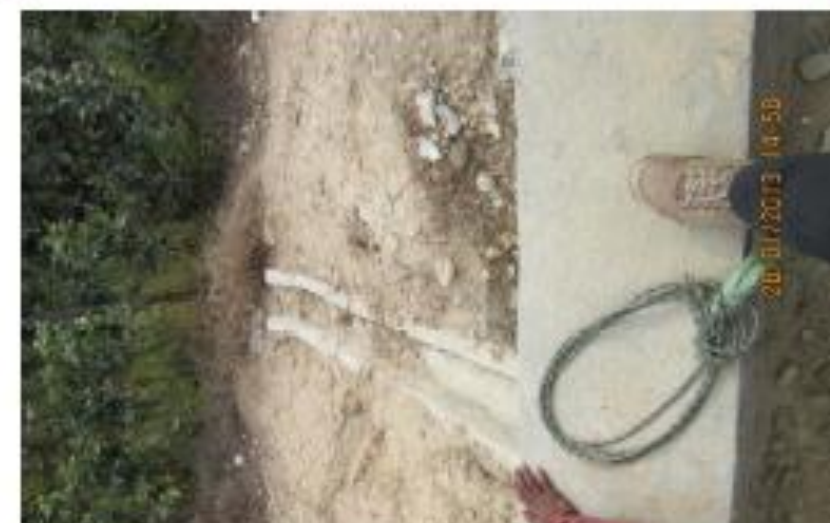
| 103+400 | Drainage outlet | Flush outlet constructed to minimize impact due to culvert discharge.(Photo:CJ6) | No action needed, It's a good practice. |

CJ6: Flush outlet constructed to minimize impact due to culvert
