**ROAD SECTOR DEVELOPMENT PROJECT (AF)**

**FINAL REPORT FOR EXTERNAL MONITORING OF ENVIRONMENTAL SAFEGAURD IMPLEMENTATION**

**(GD & KC ROAD)**

**December, 2012**

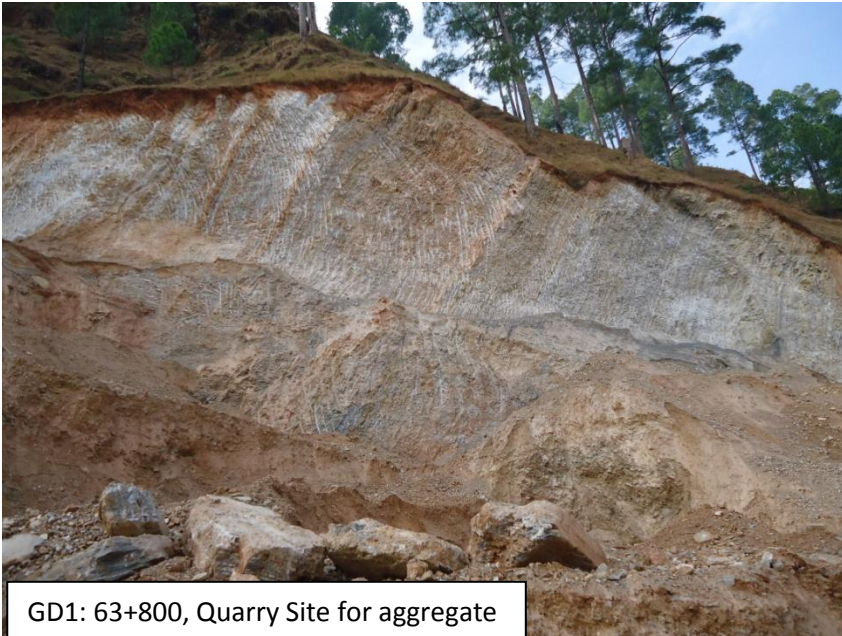
| <b>1A (Starting point : 54+000)</b> | | | |
|---|---|---|---|
| 63+800 | Quarry site | Quarrying of rocks for aggregates (photo:GD1) | Retaining structure |

GD1: 63+800, Quarry Site for aggregate

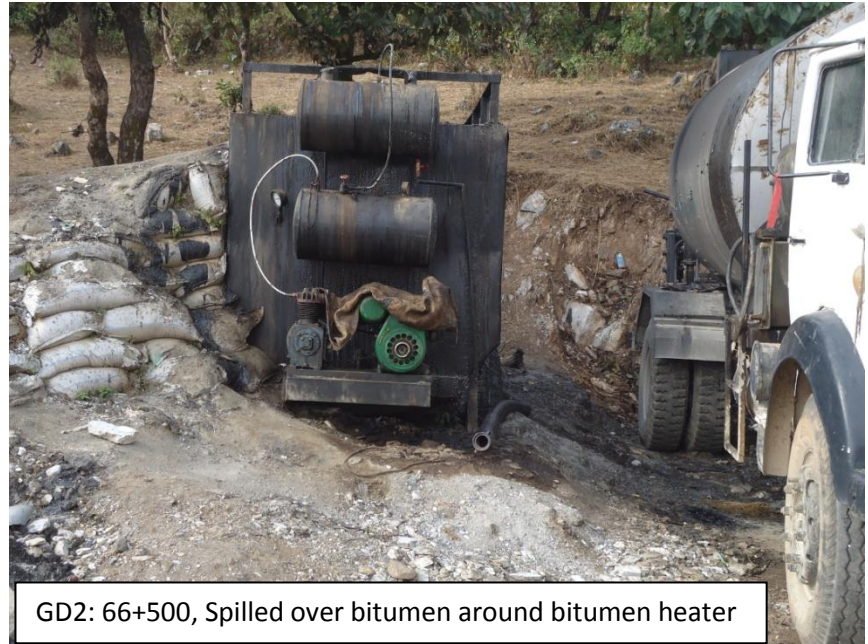
| <b>1A (Starting point : 54+000)</b> | | | |
|---|---|---|---|
| 66+500 | Storage of bitumen and fuel | Storage of bitumen was good as it was stored inside the container. But little amount of spilled over bitumen was observed around the bitumen heater. (photo:GD2) | It is suggested to clean up that bitumen promptly around the bitumen heater. As the facilities were on the process of dismantling. |

GD2: 66+500, Spilled over bitumen around bitumen heater

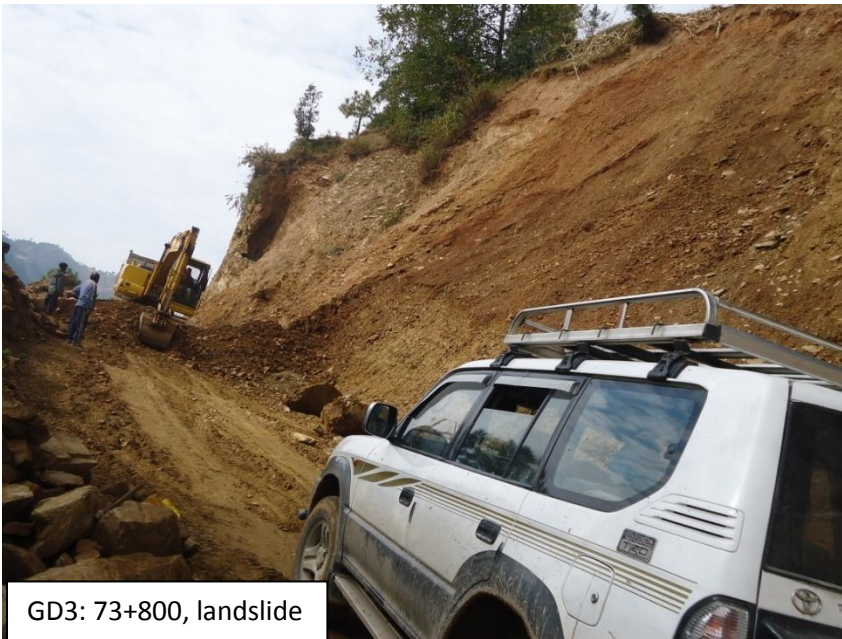
| <b>1B (Starting Point: 72+500)</b> | | | |
|---|---|---|---|
| 73+800 | Landslide | Debris fallen from the hill side repeatedly. It was deposited on the road. (photo:GD3) | Gabion wall and Bioengineering work |

GD3: 73+800, landslide

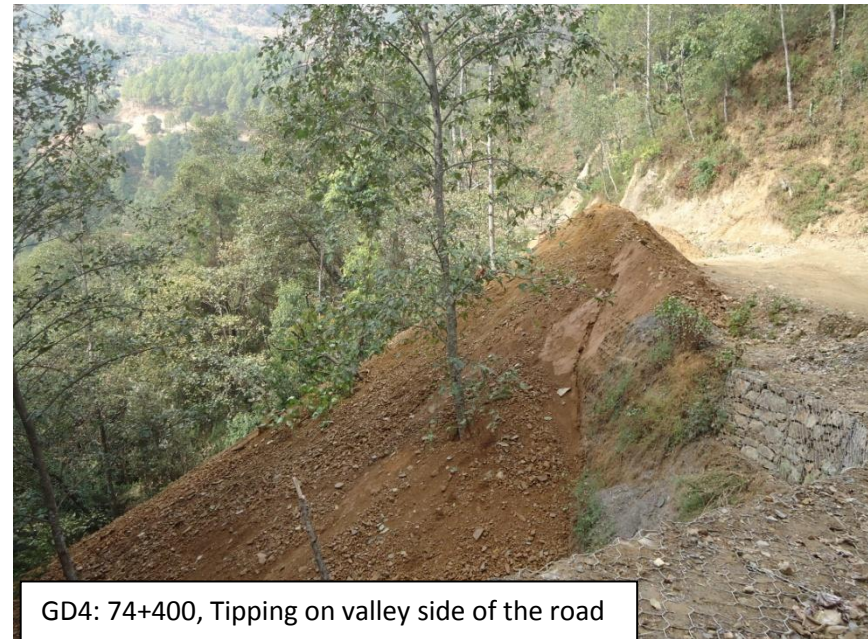
| <b>1B (Starting Point: 72+500)</b> | | | |
|---|---|---|---|
| 74+400-<br>74+500 | Tipping site | Spoil tipped along the valley side of the road (photo:GD4) | Gabion wall and Bioengineering work |

GD4: 74+400, Tipping on valley side of the road

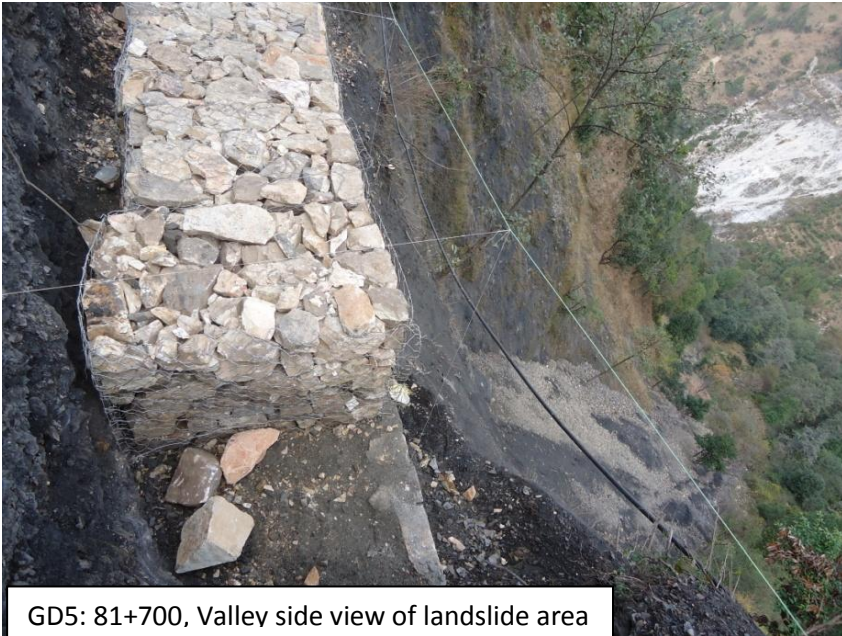
| <b>1B (Starting Point: 72+500)</b> | | | |
|---|---|---|---|
| 81+700 | Major landslide (last year) | The road alignment was swept away by this landslide last year. And new alignment has been constructed. Black soil with slate like rock fragments on the hill side. (photo:GD5) | Breast wall towards hill side. Gabion walls and bioengineering on the valley side slope. |

GD5: 81+700, Valley side view of landslide area

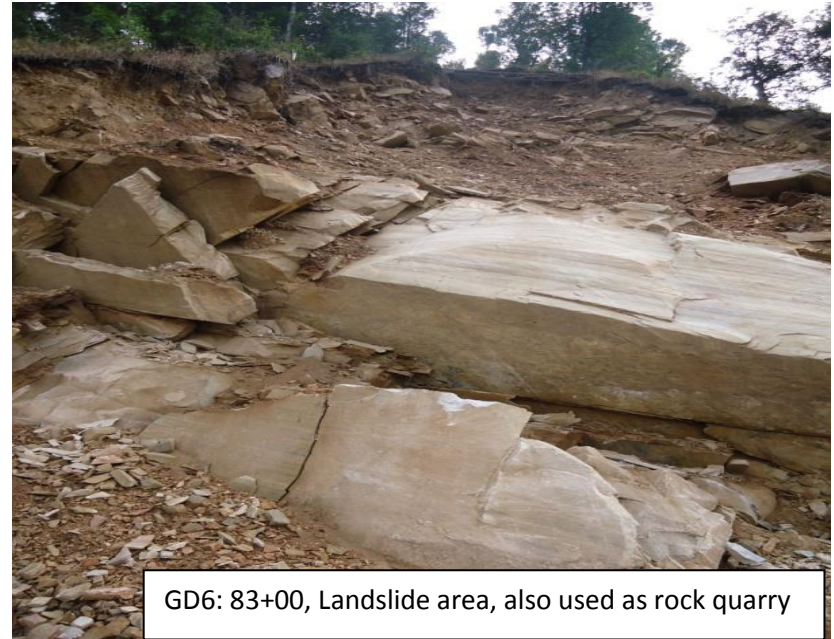
| 83+00 | Landslide area (used as quarry) | Ongoing quarry, debris with huge rocks along the hill side. (this part of the hill slope also falls within the earthwork cutting for road) (photo:GD6) | Retaining Structure and bioengineering |

GD6: 83+00, Landslide area, also used as rock quarry

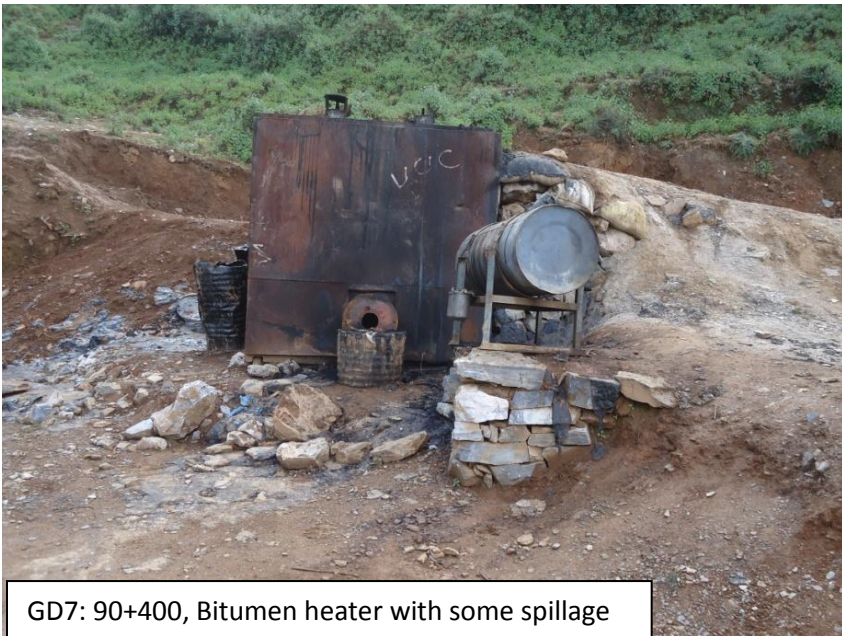
| <b>2A (Starting Point: 86+000)</b> | | | |
|---|---|---|---|
| 90+400 | Bitumen and fuel storage | The fossil fuel was stored within the metal container. Little amount of spilled over bitumen around the bitumen heater. (photo:GD7) | The spilled over bitumen should be cleaned promptly before the dismantling of the facility. |

GD7: 90+400, Bitumen heater with some spillage

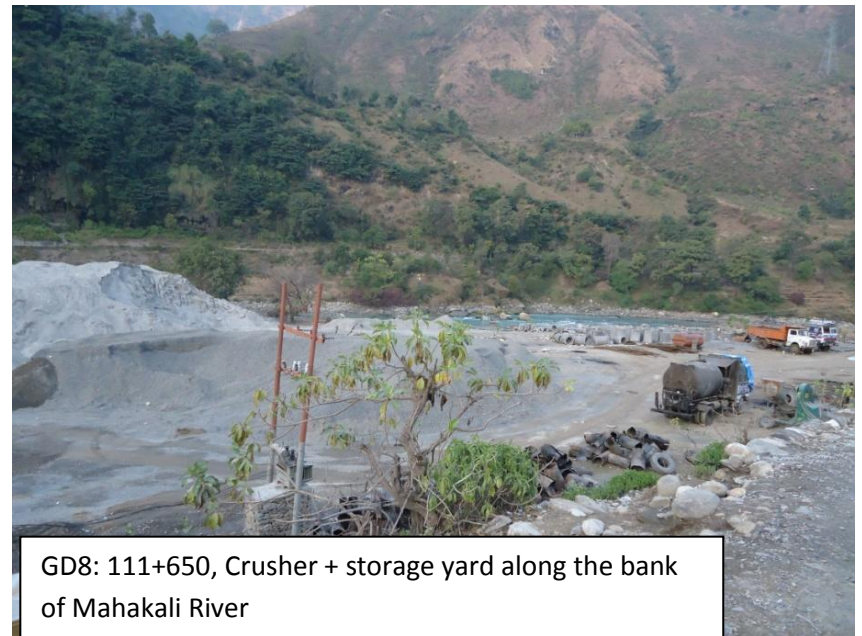
| <b>2B (Starting Point: 101+000)</b> | | | |
|---|---|---|---|
| 111+650 | Crusher yard /Casting ,<br>Storage of aggregate,<br>Sand | The storage of aggregate and sand were confined within the yard, no haphazard storage seen, but sand stocks were neither covered nor made wet.<br>(photo:GD8) | It is recommended to cover sand stocks with impermeable materials, especially during the windy and rainy season. Alternatively such stocks could be made wet by water sprinkle during windy season. |

GD8: 111+650, Crusher + storage yard along the bank of Mahakali River

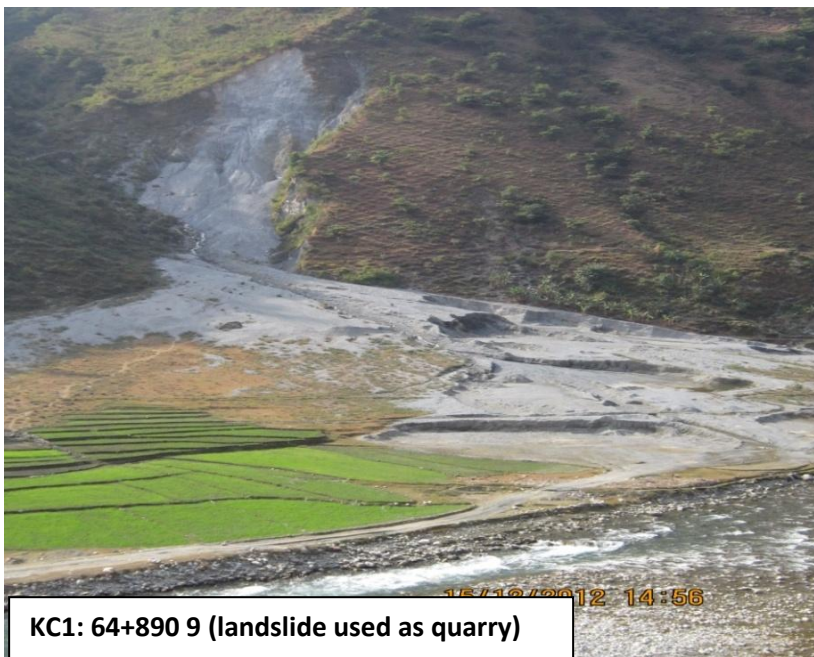
| <b>3A (Starting Point: 64+400)</b> | | | |
|---|---|---|---|
| 64+890 | Quarry site | The materials were extracted from the existing landslide on the left side of Seti River. The quarry site is being used for the extraction of sand, aggregate. (photo:KC1) | Retaining Structure. |

KC1: 64+890 9 (landslide used as quarry)

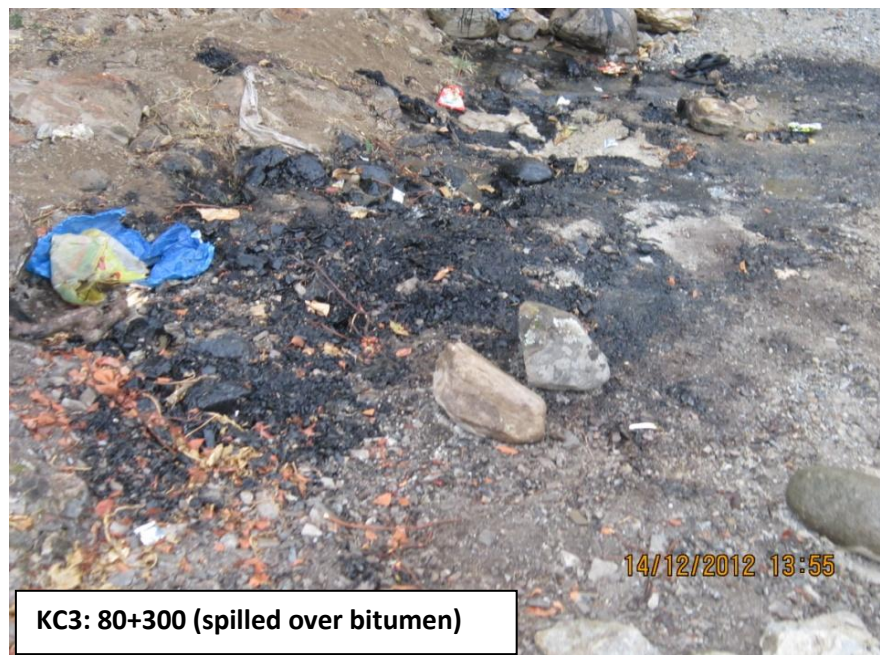
| <b>3B ( Starting Point: 76+00)</b> | | | |
|---|---|---|---|
| 80+300 (Jhanana) | Bitumen, and fuel storage | Both the fuel and bitumen were stored inside the metal container. No signs of fuel spillage noted. Little amount of spilled over bitumen were observed around the bitumen heater. (Photo KC3) | Should be cleaned up that bitumen promptly, as the facility was on the process of dismantling. |

KC3: 80+300 (spilled over bitumen)

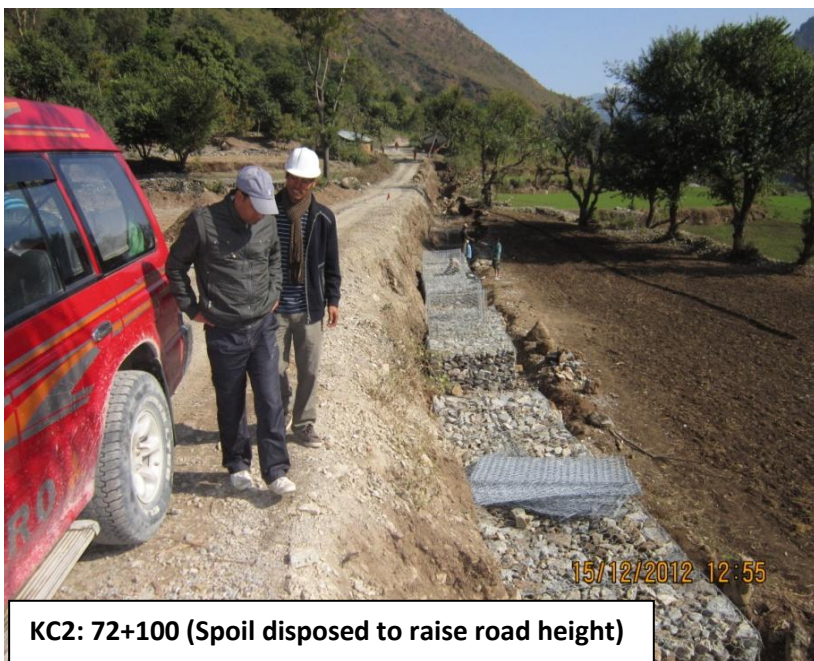
| <b>3A (Starting Point: 64+400)</b> | | | |
|---|---|---|---|
| 72+100 -72+180 | Spoil disposal | Cut materials used to raise the height of the road, spoil materials used as backfill. Gabion walls on either sides of the road are being constructed. (photo:KC2) | Good protective measures to protect road and adjacent farmlands. No further action required. |

KC2: 72+100 (Spoil disposed to raise road height)

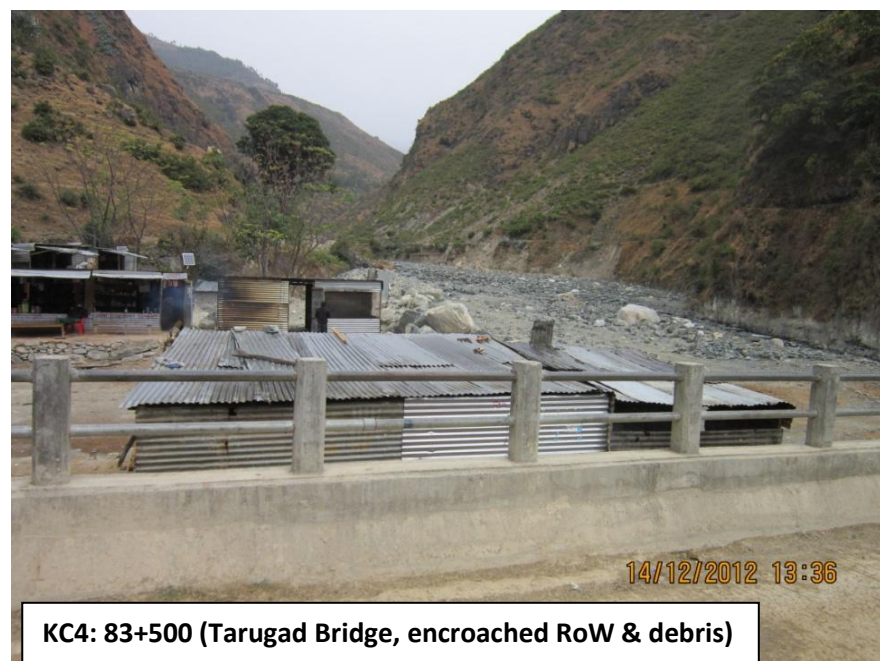
| <b>3B ( Starting Point: 76+00)</b> | | | |
|---|---|---|---|
| 83+500 | Debris deposition and encroachment | Tarugad (Pul bazaar): huge amount of debris deposition, encroachment of bridge | The encroached land should be cleared immediately to protect the bridge and the life of the encroachers |

| | of bridge RoW | RoW by local people. Very low clearance of the bridge was noted.<br>(Photo: KC4) | from flood. It is recommended to project for clearance of the debris or alternative measures for bridge protection. |

KC4: 83+500 (Tarugad Bridge, encroached RoW & debris)
