| NAME OF THE PROJECT: | CONSTRUCTION OF KARNALI RIVER BRIDGE |
| LOCATION: | KOTHIYAGHAT BARDIYA |

CONSTRUCTION OF WELL FOUNDATION  
WELL NO. 4

## INTERRUPTION DURING WELL SINKING OF WELL NO.4

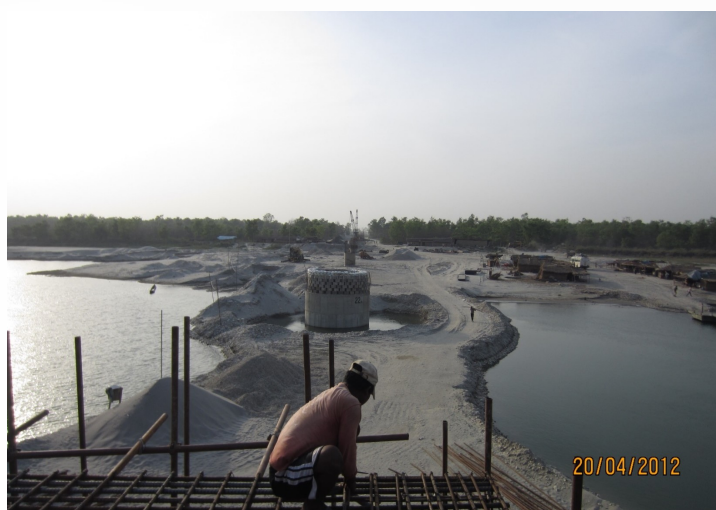
After monsoon well sinking operation resumed on well no 4 continuously engaging one crane till june,2012. No well movement was found.

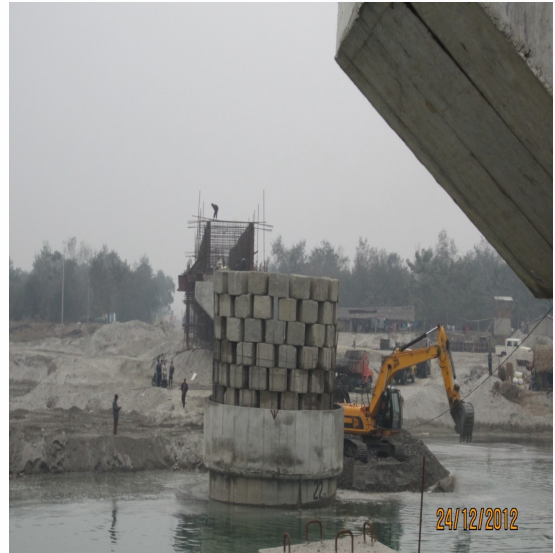
Since there was no evidence of any Wooden logs, and the rock found below the cutting edge as per Diver and the Crane operator there could be the one reason among the last 2 situation mentioned above

Since, despite of the continuous dredging effort no sump was made below cutting edge, it was revealed that the most likely situation could be

- **Loose sand/silt below stiff clayey layer**

Continuous Inflow of river bed material below the cutting edge which prevents the formation of Sump.

To increase the Hydraulic Pressure at the bottom of dredge hole than the pressure outside of the well.

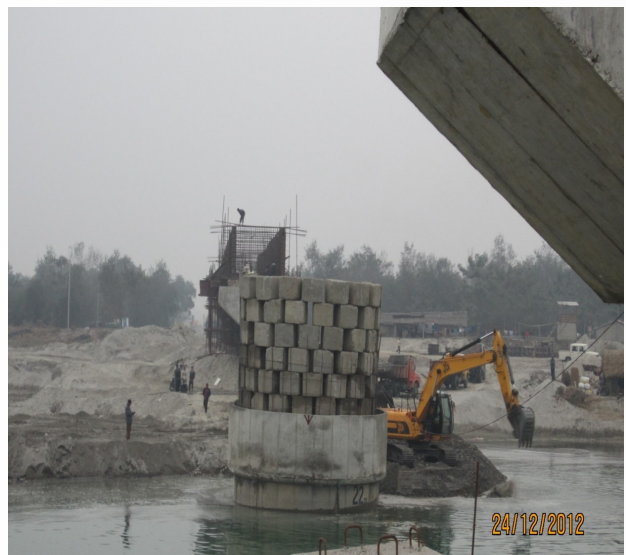
- PRESENCE OF DIFFERENT LAYERS OF SOIL

- SINKING PROBLEM

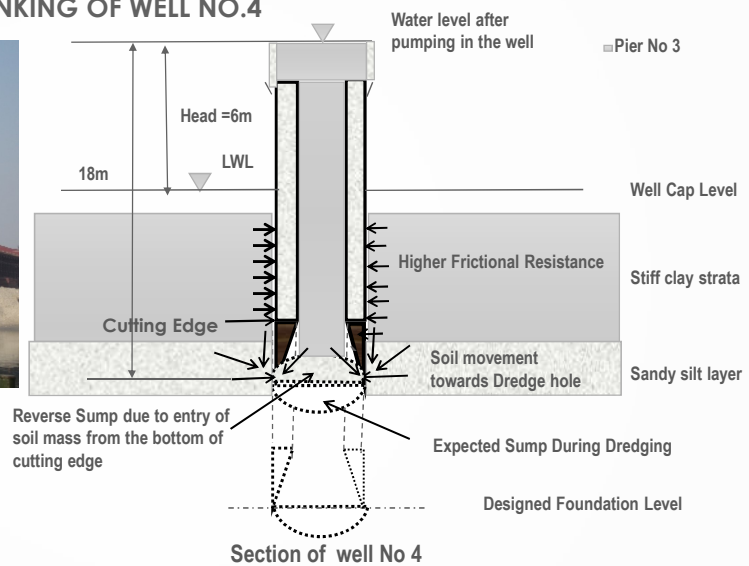
Day 2 : hair line crack noticed between the outer surface of the well and the soil

Day 3 : widened crack noticed but still sinking was not achieved.

Widened crack hinted that there is considerable movement that caused widened cracks on a well which remained stationary for a long time.

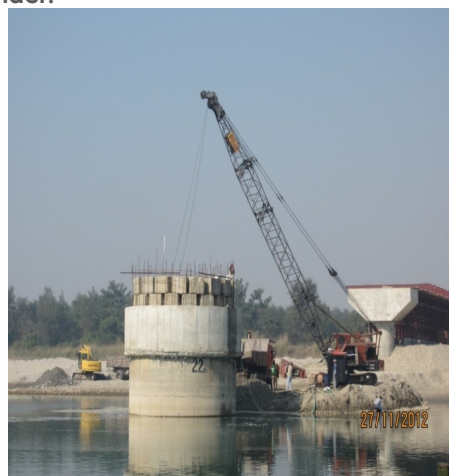
WELL BEFORE PUMPING IN

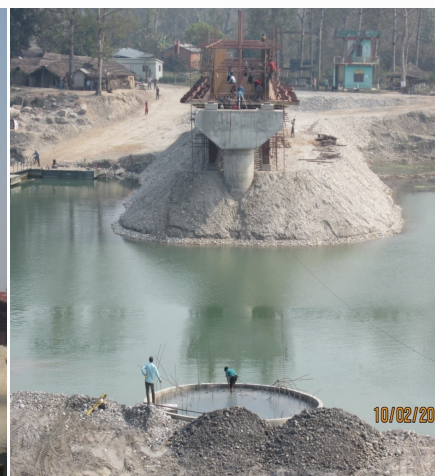
COMPLETION OF WELL SINKING

As anticipated in day 3, well sinking was achieved from day 4 and well sinking was completed on day-17. Record of well sinking was as under:
