RECTIFICATION ON TILTING OF WELL BY KENTELEDGE  
METHOD INCLUDING PROBLEM ENCOUNTERED ON  
FORMWORK  
DURING CONSTRUCTION OF KARNALI BRIDGE,  
KOTHIYAGHAT ,BARDIYA  
- A CASE STUDY

PRESENTED BY :ER.GANESH KUMAR GAUTAM

02/01/2013

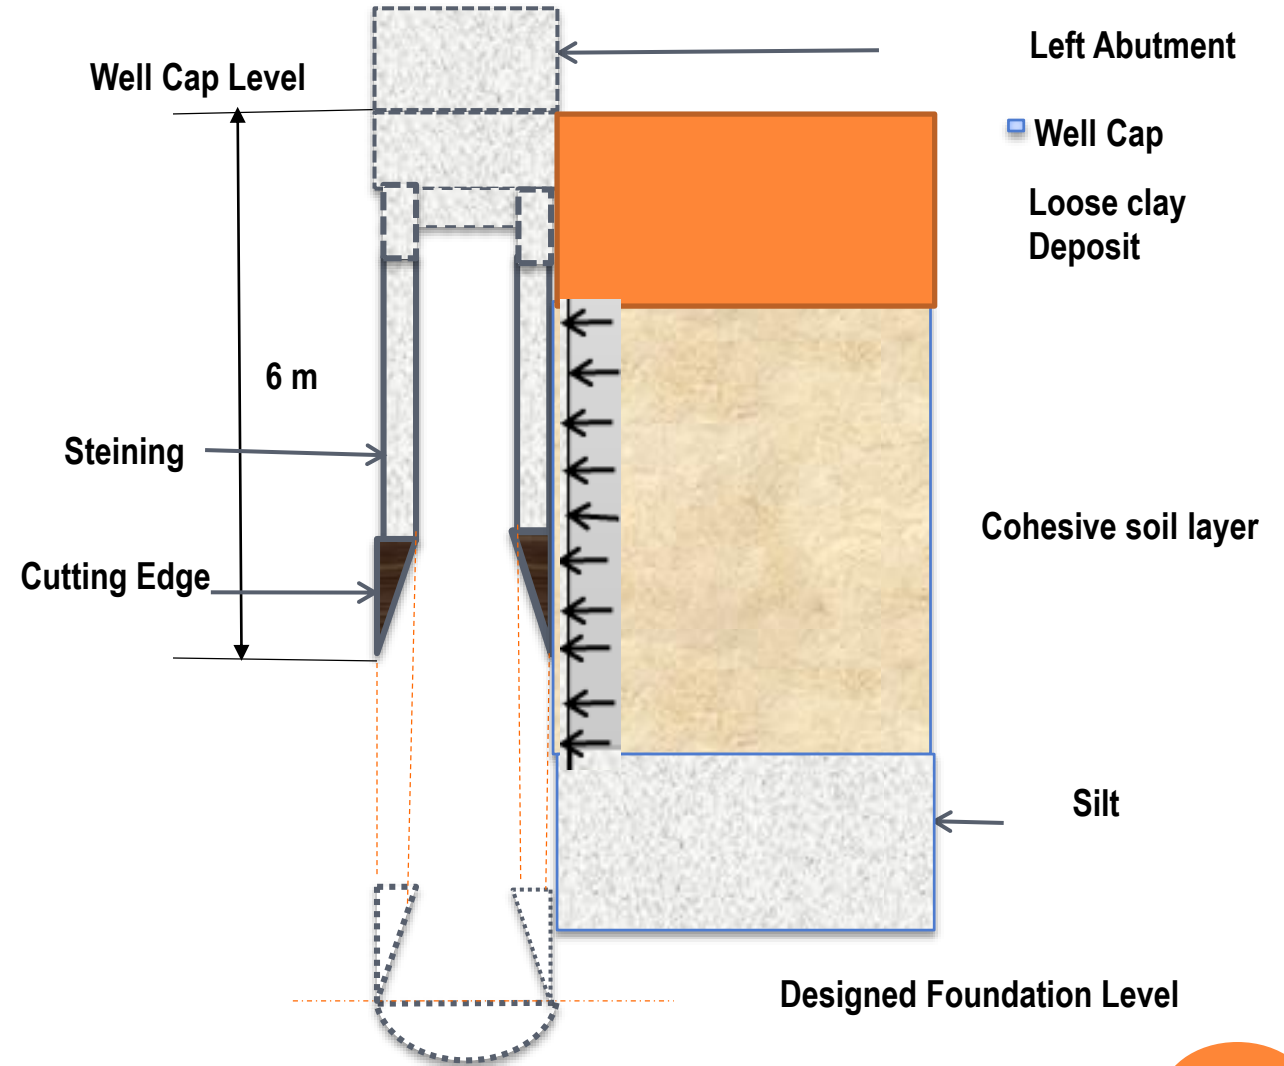
Section of well Foundation

After sinking of curb each lift of 2m were sunk by grabbing method. Till the depth of 6m from Ground Level well sinking was achieved smoothly. During the sinking of next lift the well was tilted by 4 cm due to the presence of highly cohesive soil layer.

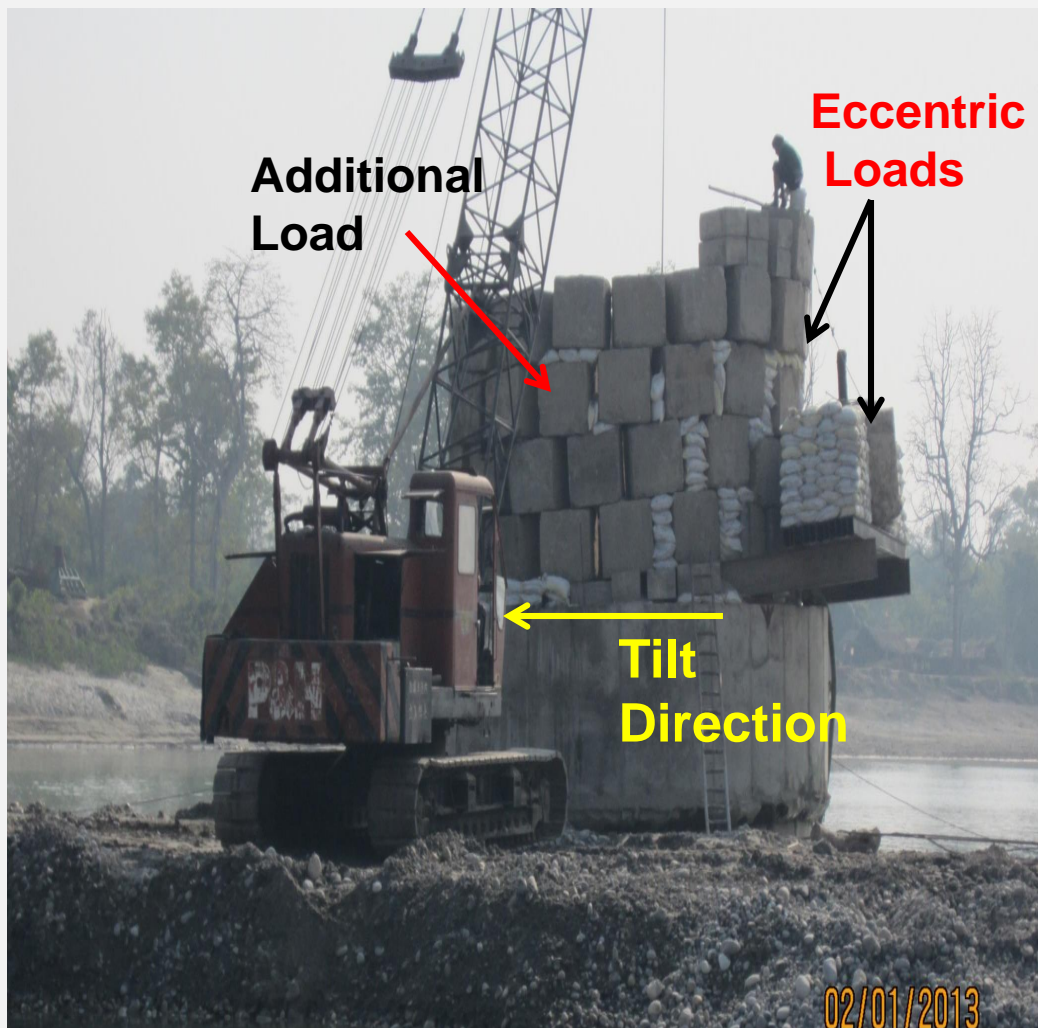
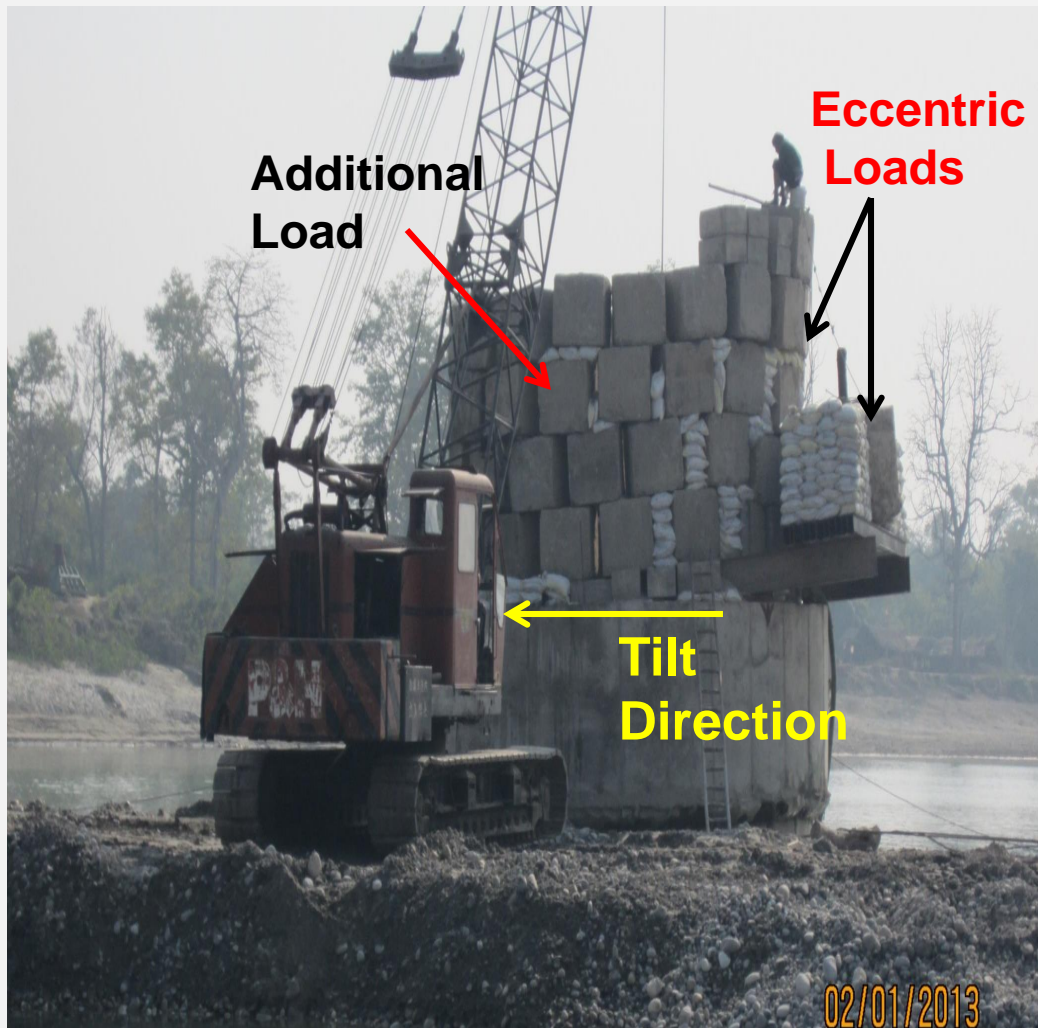
- 6 cm Tilt was corrected during further 6m sinking
- No further Tilt correction was achieved during the sinking between 18 – 24 m depth
- Final Tilt remained was 4 cm .  
Since the tilt was well below the limit, the Bottom Plugging was done on that condition

- **Kentledge loading of adequate weight at required distance from well axis was placed eccentrically on the higher side of the well**

- **Additional weight for a height of 5 m was put in the form of concrete blocks on top of steining.**

- **Sinking continued by grabbing materials against the tilt.**

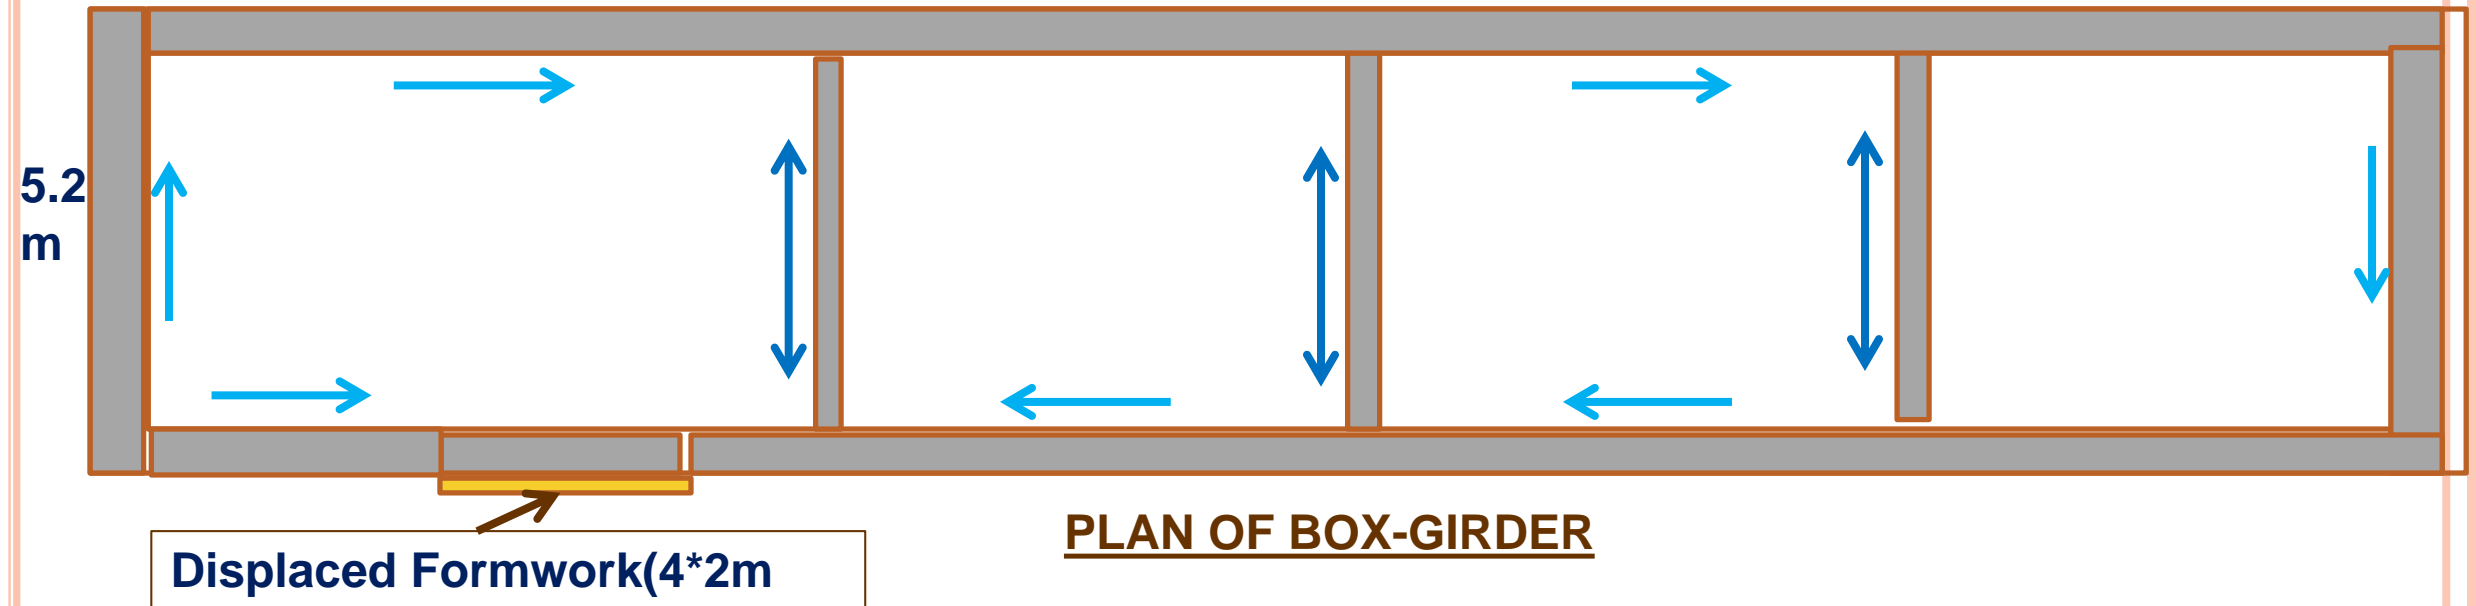
Location: Span No.5 (First Web Concreting)

**Problem:** Formwork at the base of web with area(4\*2) m displaced from the position during concreting when approximately 30 cu.m of concrete was already been placed with average 30 cm depth covering whole area of the section.

**Cause:** Pumped Concrete with the use of water reducing Admixture, caused high pressure when the concreting was done for a full depth of 3.2m at that section.

**Result:** Concrete Flowing down from the bottom of the Web from all around the web, End and Intermediate girders as shown in the Figure above.

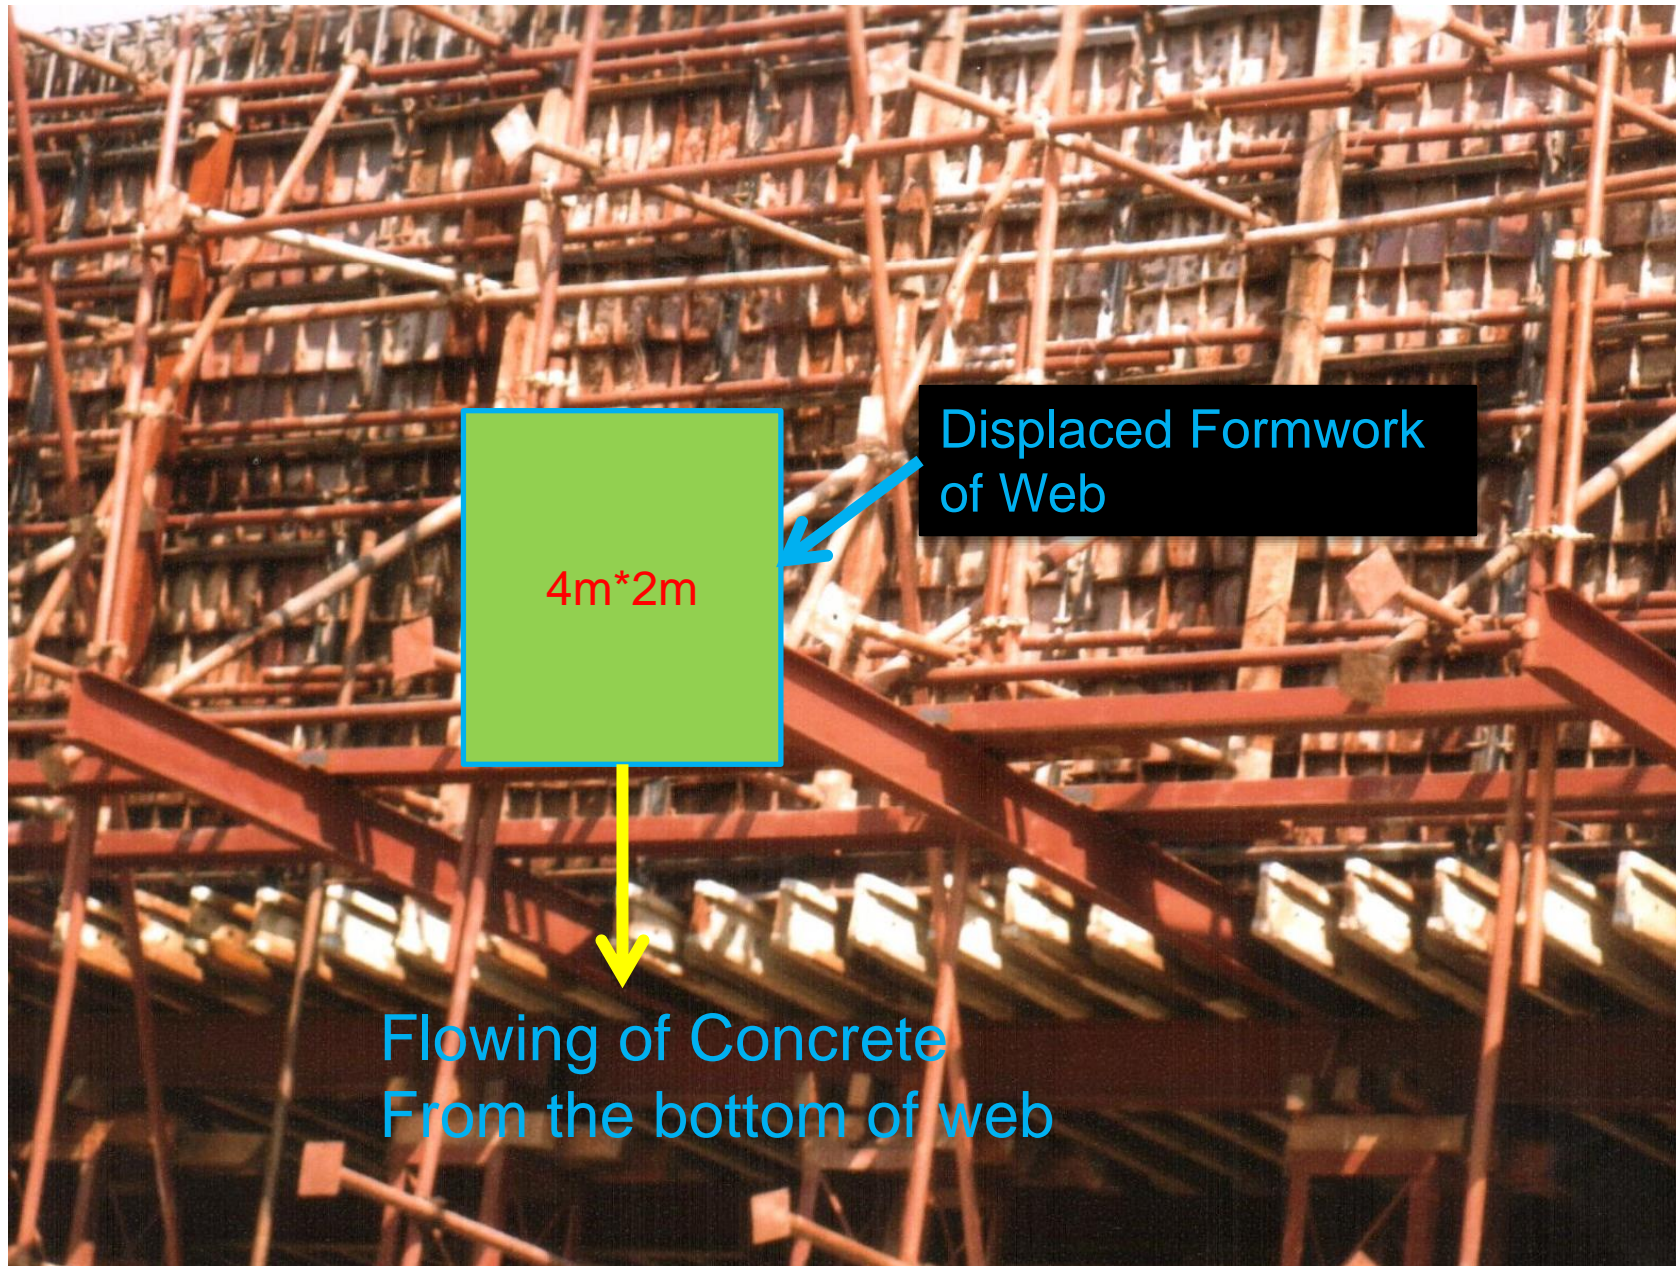
Defective form work displaced due to fluid Pressure on Web of Box-girder at span 5
