## Problems and practical solutions taken during contracts with respect to real cases in Bridge construction

Kathmandu 2076/11/28

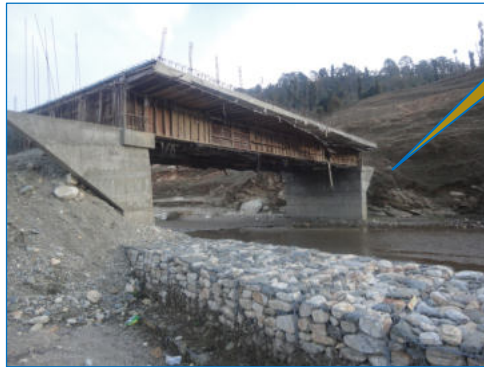
## Design ?

Bridge Span  
adequate ???

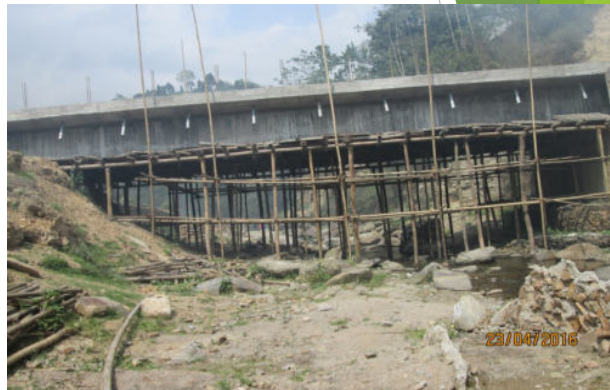
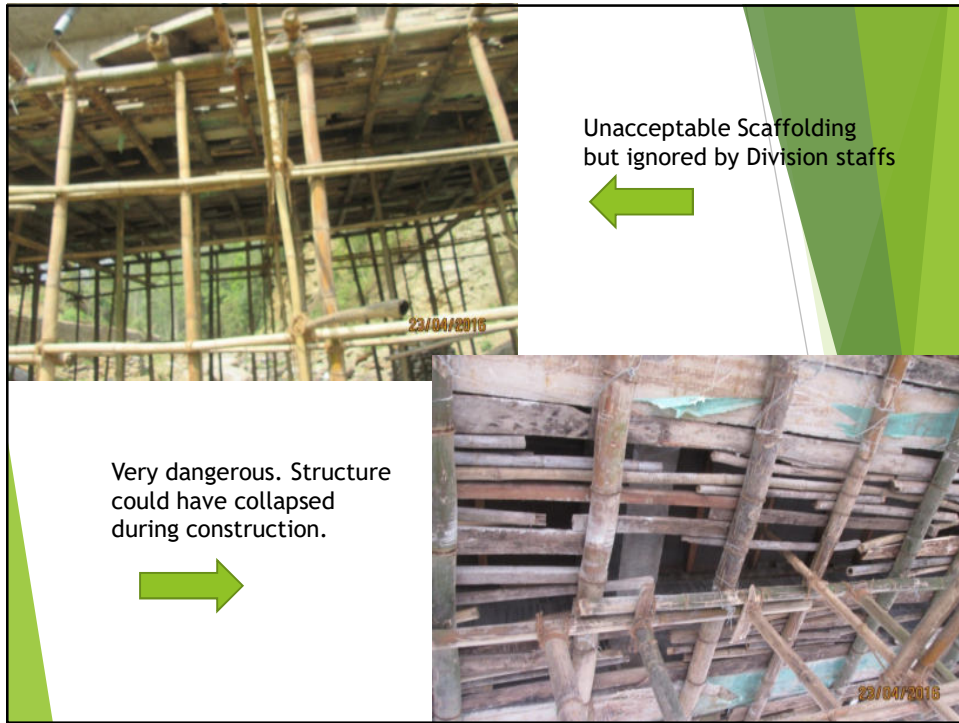
## Staging and formwork

- ▶ No base plates below the bamboo props. Some of the props are rested on boulders.
- ▶ No proper bracings.
- ▶ Differential settlement could have taken place.
- ▶ Nothing ac Bamboo props should not be preferred for longer spans, cording to the specification.

Unacceptable Scaffolding  
but ignored by Division staffs

Very dangerous. Structure  
could have collapsed  
during construction.

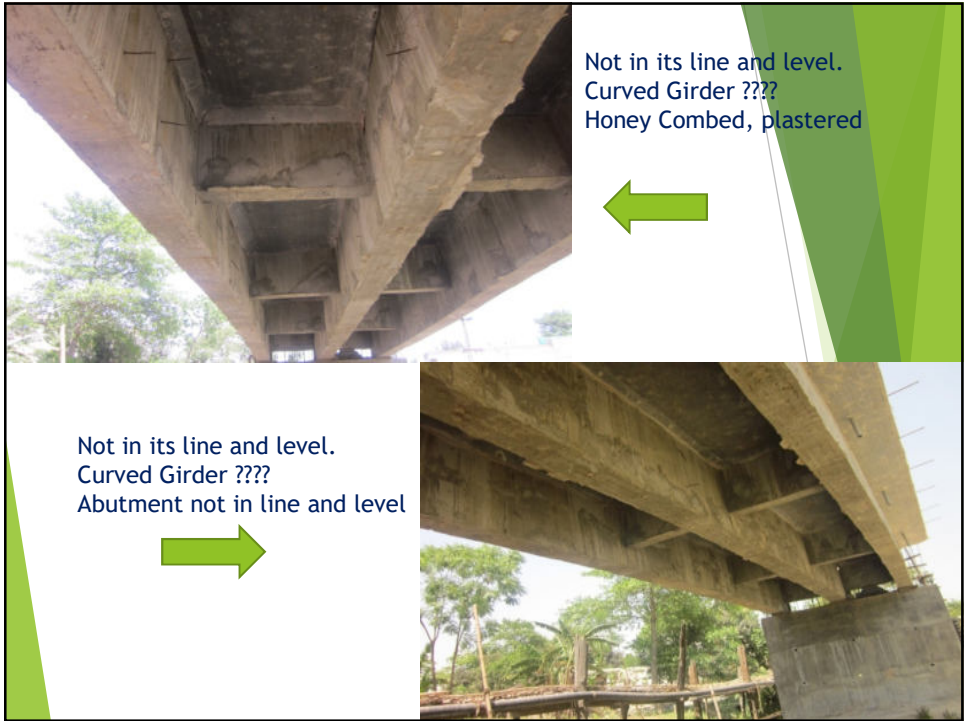
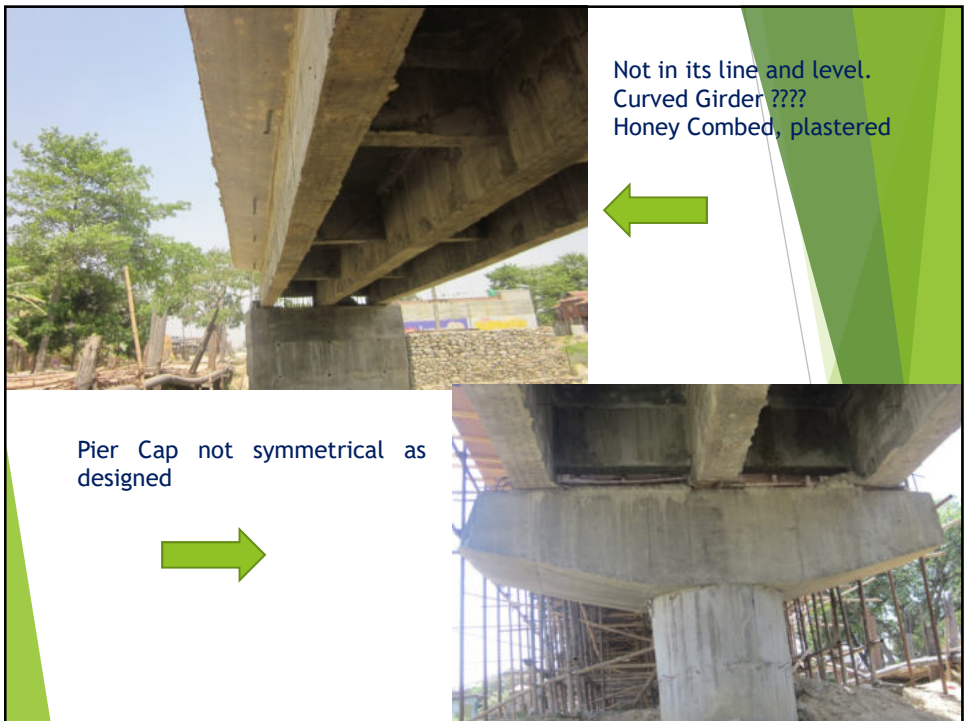
Formwork not secured properly  
Not in line & Level

Adjusting devices shall be  
secured against movement  
during concrete placing

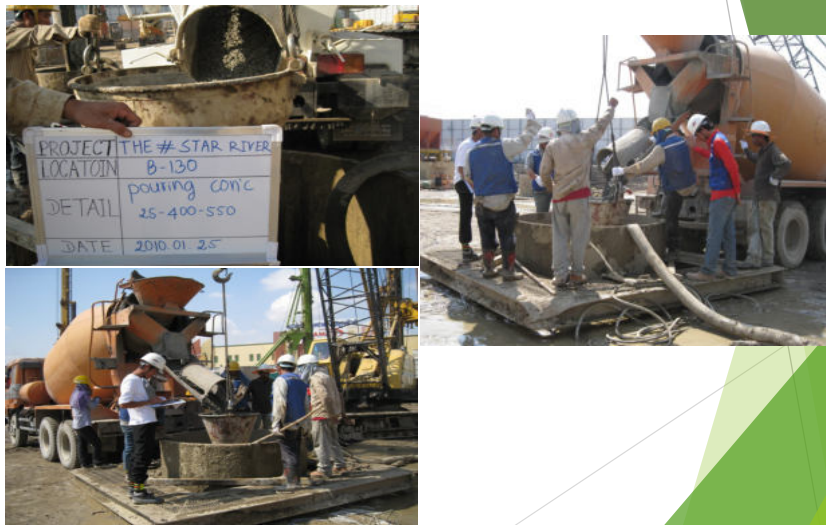
## Pouring the concrete

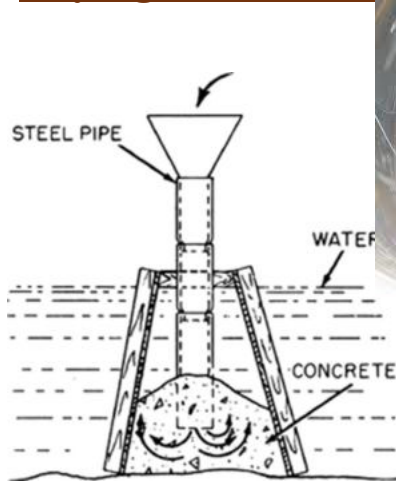
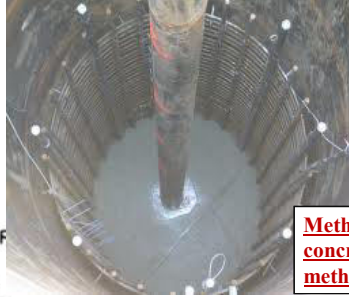
Method of underwater concreting— Tremie method (inside view)

Basic principle behind Method of underwater concreting - Tremie method

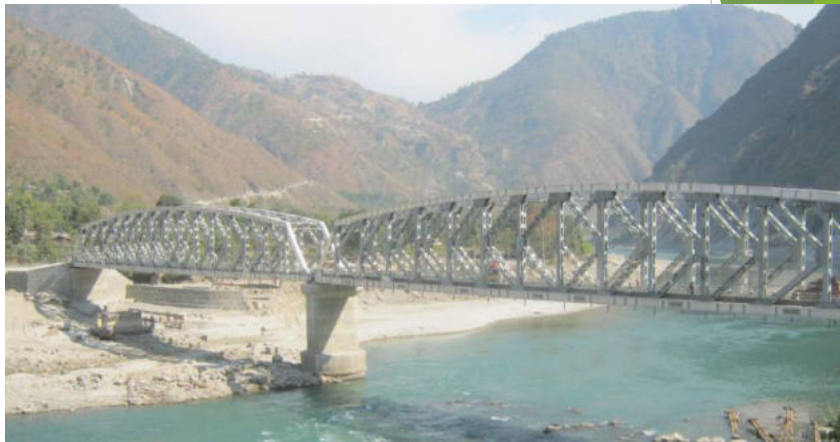
## SUNKOSHI BRIDGE, GHURMI.....

- ▶ Two Spans of 85 m of K-type truss
- ▶ One Pier and two abutments
- ▶ All foundations were well
- ▶ Designed Depth of foundation were 14 m
- ▶ Well could sink only up to 10 m in one well and 12 m in two wells
- ▶ Wells struck to large boulders in the river bottom
- ▶ Tilt and shift exceeded the limit of 1 in 80 and 15 cm respectively
- ▶ Construction was stand still till 2069 BS

► Delay of Bridges designs by consultants

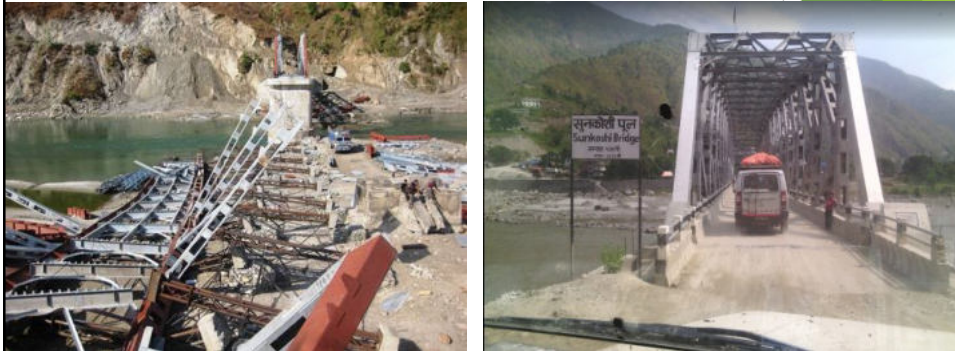
## SUNKOSHI BRIDGE, GHURMI.....

- ▶ Problem was solved by introduction of micro-piles
- ▶ 16-19 Nos of micro-piles of 30 cm dia with depth 10 m were provided to anchor the well in rock
- ▶ Three wells were not in a straight line due to shift
- ▶ Skew design check was done and constructed accordingly
- ▶ Well caps are above river bed level
- ▶ Reinforcement of the well were cut by public
- ▶ Reinforcement were exposed by dismantling 20-30 cm of well and reinforcement were socketed and slightly welded
- ▶ Epoxy grouting were used to fix the reinforcement

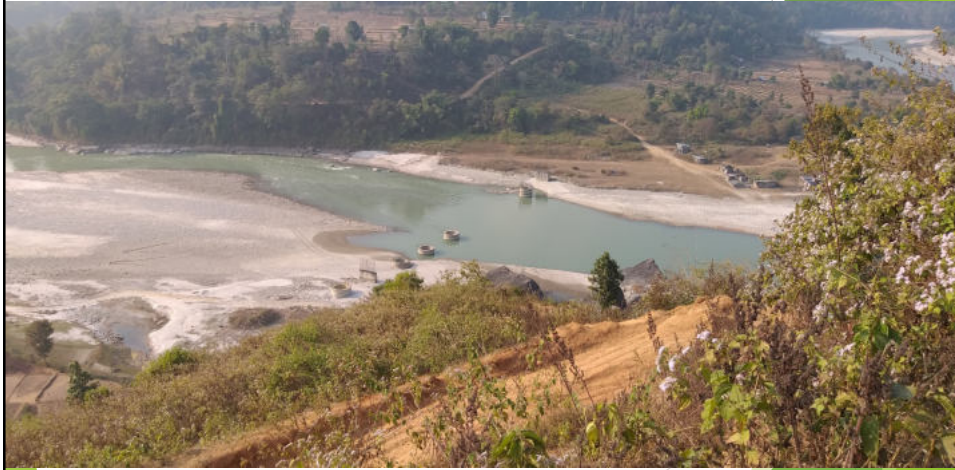
## Arun River bridge, Sankhuwasabha Lamsuwaghat

- ▶ 5 Spans: one steel truss and 4 RCC spans total length 144.6 m
- ▶ Abutments Open foundation, Piers 7 m dia wells 14 m deep
- ▶ Contract was signed in 2069 BS
- ▶ EoT was approved up to 2074 BS
- ▶ Amount NRs 130.540 mln
- ▶ Confirmatory drilling and design check was conducted by the Contractor
- ▶ No objection by the Contractor during design check
- ▶ Probably no offset may be provided at the well curb to minimize the skin friction

- ▶ Well sunk till date were 11m, 12m, 10 m, 7.5 m and 3 m
- ▶ Designed depth is 14 m
- ▶ Contractor demobilized all machines and manpower last year
- ▶ Only one watchman is at the site
- ▶ The Contractor claims an alternate designs
- ▶ Ask to convert well foundation to pile
- ▶ Progress till date is 27%
- ▶ DRO published a notice calling Contractor to the work

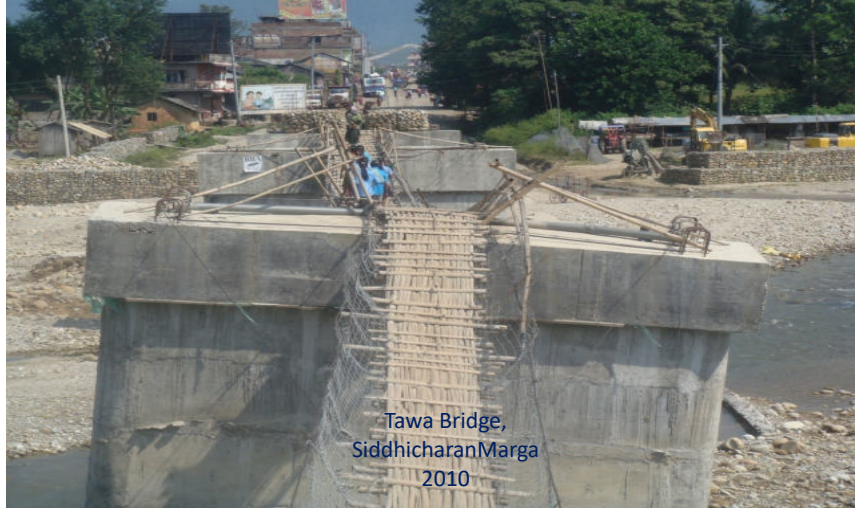
## Tawa Bridge, Siddhicharan Highway

- ▶ Bridge was designed as 5 spans of 25 m each
- ▶ Open Foundation
- ▶ Depth of foundation was only 2 m from bed level in the drawing
- ▶ The Contractor suspected the design and ask to change
- ▶ DRO Lahan did not listen to it and directed to continue work
- ▶ Constructed as per drawing
- ▶ Two piers were tilted during monsoon
- ▶ Investigation was done by DoR
- ▶ The Consultant agreed that he had done mistakes in the design
- ▶ The Consultant redesigned the foundation free of cost

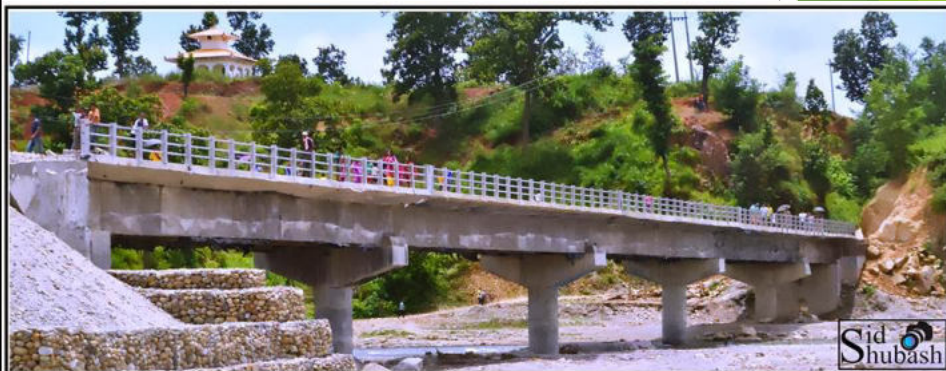
## Tawa Bridge, Siddhicharan Highway

- ▶ Tilted piers were dismantled and reconstructed as per new design
- ▶ Extra cost incurred due to demolition was NRs 66 lakhs
- ▶ CIAA investigated the case
- ▶ Consultant and the Contractor paid NRs 66 lakhs as a penalty

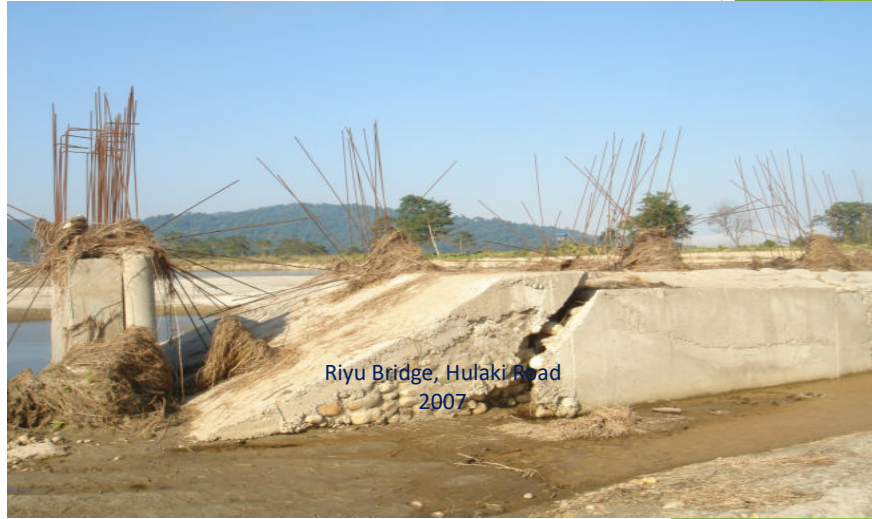
## Riyu Bridge, Postal Road chitwan

- ▶ About 250 m long vented causeway was designed and tendered out in 2006
- ▶ The partial construction was damaged by 2007 flood
- ▶ Construction was abandoned
- ▶ Later a bridge was designed

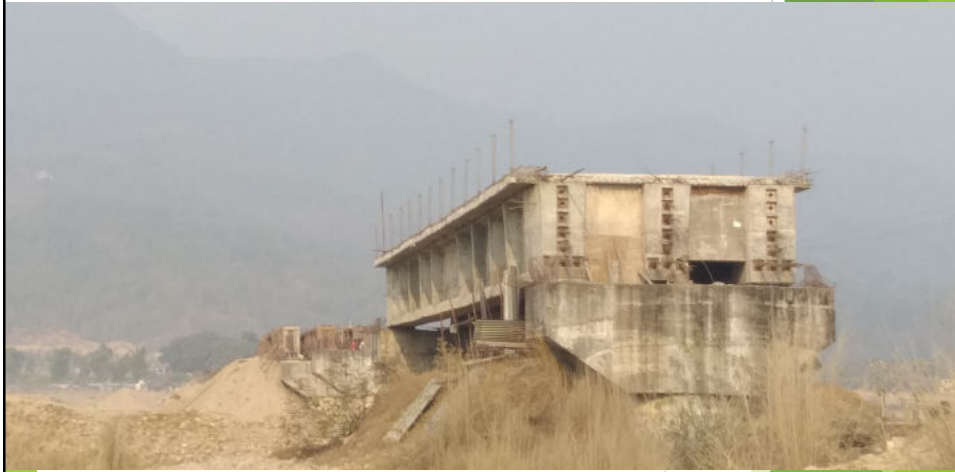
## Kamala Bridge, Sindhuli

- ▶ 547 m long PSC bridge
- ▶ Hetaunda - Sindhuli - Katari - Dharan Road
- ▶ Contract agreement on 2068.03.31
- ▶ Contract period after EoT 2074.04.15
- ▶ Contract Value NRs 301.670 million
- ▶ Open Foundations
- ▶ 14 spans
- ▶ Designed and Build modality
- ▶ About 60% Progress till date

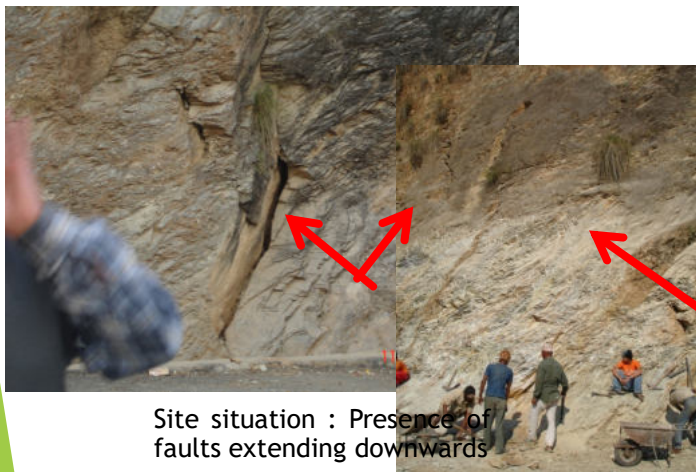
Site situation : Presence of faults extending downwards

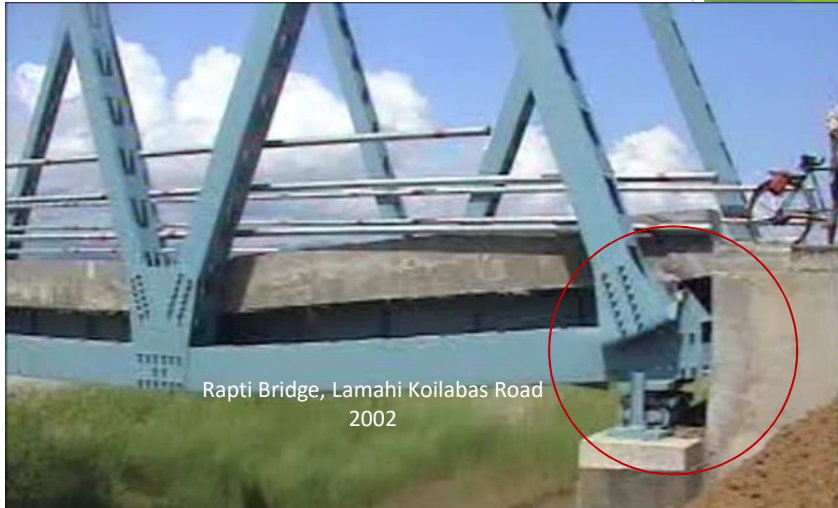
## Rapti Bridge, Lamahi Koilabas Dang

- ▶ About 404 m long steel truss cum RCC bridge was constructed in 2002
- ▶ Lamahi Koilabas Road
- ▶ Gusset plate buckled and bridge was sagged
- ▶ Investigation by various agencies started
- ▶ DoR found that the stiffness of gusset plate was inadequate
- ▶ Contractor took full responsibility and reinstated the bridge and opened the traffic to its capacity
- ▶ The Contractor rectified the problem on their cost
- ▶ Flood of 2008-9 overtopped the banks and approach road was washed away
- ▶ RCC spans were added later with separate contract later

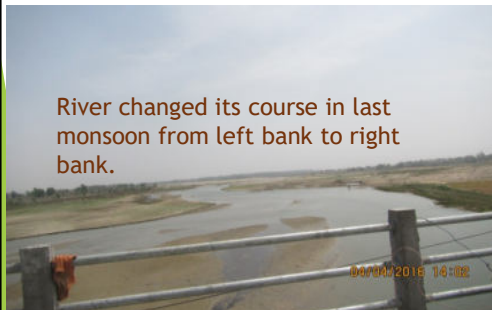
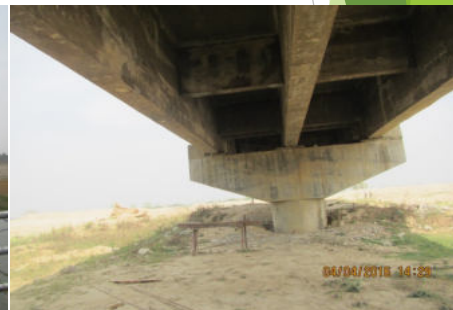
River changed its course in last monsoon from left bank to right bank.

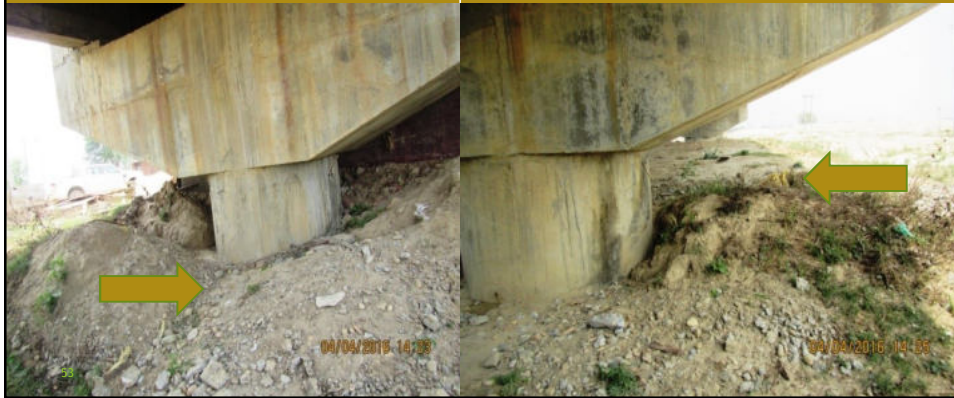
The waterway under the soffit level of bridge shall be made clear before monsoon.

Waterway is blocked by debris.

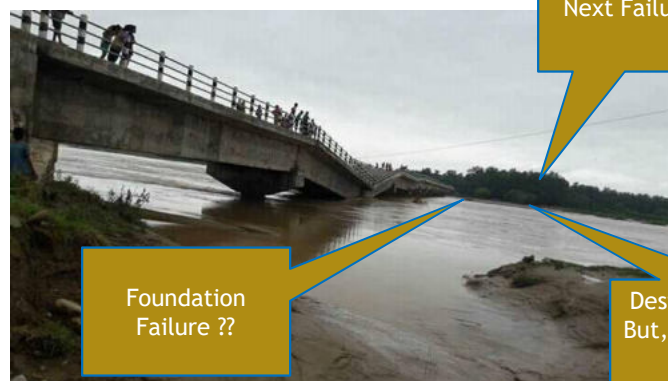
Next Failure ??

Foundation Failure ??

Designed span is 25.0 m  
But, some spans are 21.5 m  
and some are 26.5 m

- ▶ Contractor notified the Division that Drilling is hard for pier Nos 2,3,5,15 and 16
- ▶ Confirmatory bore holes indicated that SPT value were higher than designed one
- ▶ Contractor requested to change the foundation from pile to Well
- ▶ Soil embankment built for staging was not cleared before monsoon
- ▶ Pile load test was conducted for Piles of pier No 10. It was 80 ton for a settlement of 5.09 mm, it is higher than designed 59.7 ton
- ▶ Technical audit was conducted by NVC and found four NCRs
- ▶ Contractor did not corrected the NCRs
- ▶ Constructed Deck level was not smooth and equal. Right abutment is 20 cm higher than left abutment

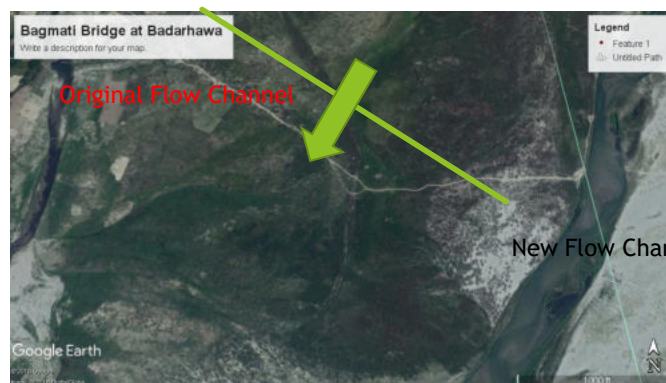
## Bagmati river shifted towards east

- ▶ River flowing about 1 km east of the bridge site
- ▶ Postal Highway project had instructed to halt the construction works in 2070 and work was abandoned in dilemma
- ▶ It is already 4 years now
- ▶ New hydrology was studied by Professors of IoE Pulchowk Campus
- ▶ It was found the HFL of the original design is inadequate to accommodate 100 years return period
- ▶ The free board is insufficient
- ▶ Later it was decided that the bridge pier cap should be raised by 20 cm only reducing available free board by 1 m
- ▶ Some strengthening at the abutment is sought
- ▶ Now the Project has instructed the Contractor to resume works
- ▶ The Contract is in process of Arbitration

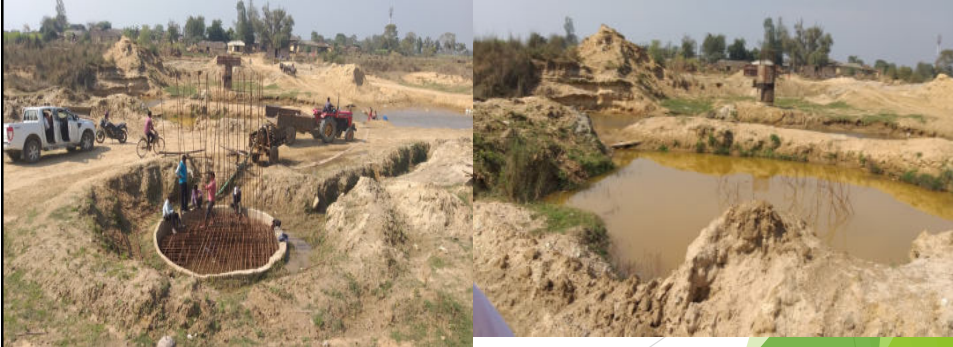
## Ektanga Bridge Parsa

- ▶ Small RCC T beam bridge 3 spans of 24 m each
- ▶ Contracted out in 2068 BS
- ▶ Contract Amount NRs 2.14 Crore
- ▶ Original Completion date 2070.04.27
- ▶ Less than 50% progress
- ▶ CIAA started investigation
- ▶ Pappu Construction
- ▶ Well foundations of 14 m deep
- ▶ Division started termination this year
- ▶ Work was abandoned by the Contractor
- ▶ Contractor resumed the work after notification of Termination

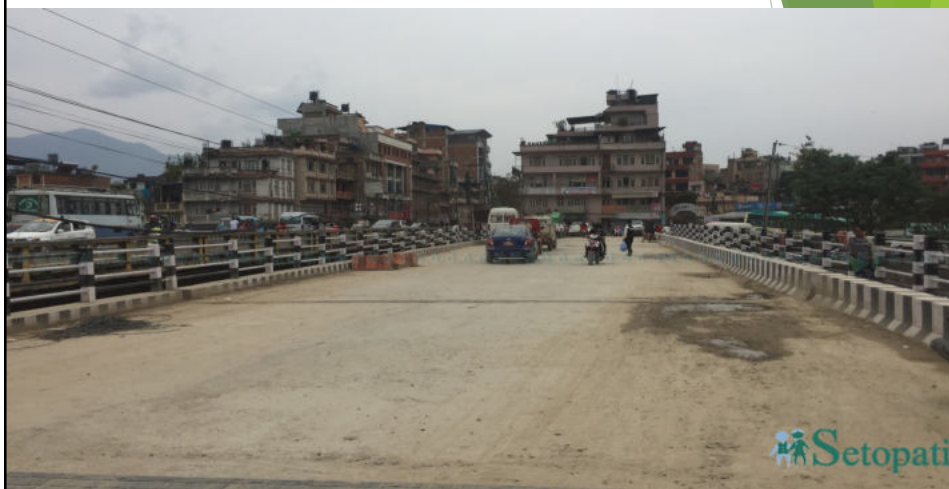
## Bishnumati Bridge, tekū

- ▶ A Contract of Kathmandu Sustainable Urban Transport Project under ADB finance
- ▶ Design and Supervision by Consultant
- ▶ ICB Contract in 2013
- ▶ Contract Amount about NRs 22 Crore Two bridges (Dallu Arch bridge and Teku Bridge)
- ▶ Original Completion date 2016
- ▶ ZEIC - Pappu JV
- ▶ Pile foundations of about 22 m deep
- ▶ Deck of Dallu bridge completed but approach not final yet
- ▶ Traffic cannot utilize the Dallu bridge due to incomplete approach road
- ▶ ADB loan closed last year
- ▶ Project terminated and handed over to Kathmandu Division

- ▶ Consultant ask the Contractor for Trial Mix of the Concrete
- ▶ Designed Concrete strength was M45
- ▶ Contractor did not respond to the Consultant's instruction
- ▶ Consultant ask the Contractor for Test certificate and confirmation of Prestress strand
- ▶ A sample was sent to IoE, the result was about 1200 Mpa but required was 1800 Mpa
- ▶ 3 Span bridge, two side spans of RCC 20 m and central PSC girder 30 m span
- ▶ PSC span to be completed first because of inadequate space provided at Pier Cap
- ▶ Contractor completed RCC spans first
- ▶ Nos space available for Prestress Jack
- ▶ A part of RCC span was dismantled and Prestress Jack was placed to the position in one side only
- ▶ Prestressing tension was given from one side only

- ▶ The Contractor cut all the exposed tendons immediately, Consultant could not get samples
- ▶ The test result was available after the installation of tendon and had inadequate strength
- ▶ Concrete was also found of inadequate strength
- ▶ Due to this the Consultant ordered to dismantle the PSC span
- ▶ Later the Contractor showed a test result of unknown sample of Prestress strand

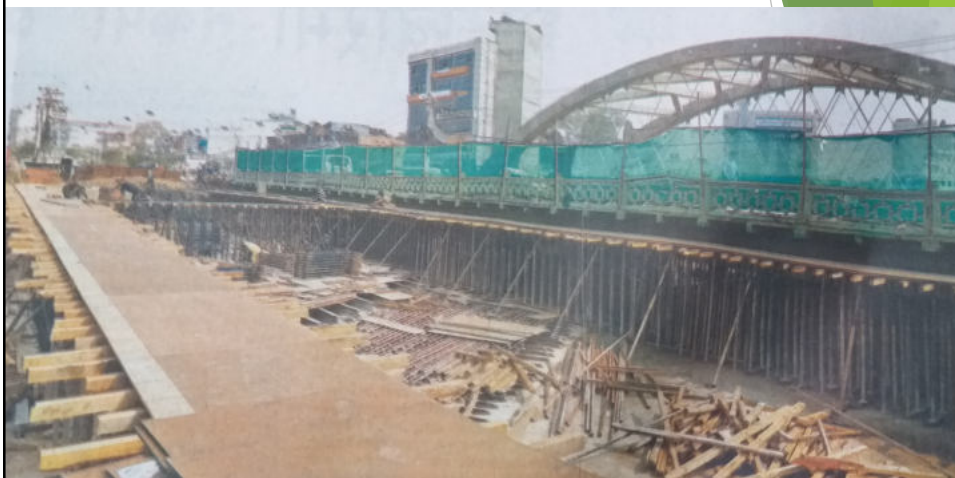
## Dhobi khola bridge Bijuli Bazar

- ▶ Design and Build modality
- ▶ Agreement on 2071 Poush 13 with the Contractor
- ▶ Original Contract period was up to 36 months
- ▶ EoT was granted till 2076.09.13
- ▶ Contract Value NRs 131.4 million
- ▶ Construction of two bridges on Dhobi Khola of Araniko Highway at Bijulibazar
- ▶ Survey, soil exploration, detailed design and environmental studies to be conducted by the Contractor
- ▶ Contractor Bid for the design and studies
- ▶ Construction of the bridge as per approved design and specification including foundations, substructures, super structures and other ancillary works all complete as a single item as 1 Job in the BoQ
- ▶ Construction of Approach road as per the approved design with necessary ancillary works 1 Job in the BoQ

- ▶ River Training and Bridge protection works as per approved design 1 job
- ▶ Design was done by Bangladeshi Engineers of BUET
- ▶ Provision for EMAP implementation
- ▶ 12m wide bridge was designed and approved after survey, geotechnical investigation by the Contractor
- ▶ It was found 10.0 wide bridge could be constructed on u/s side due to objection of the local people
- ▶ Redesign and approval process took almost 6 months
- ▶ Now the construction has started
- ▶ WS trunk pipe line was found parallel to the foundation
- ▶ Sewer line and underground electric line was also found in the foundation and later shifted

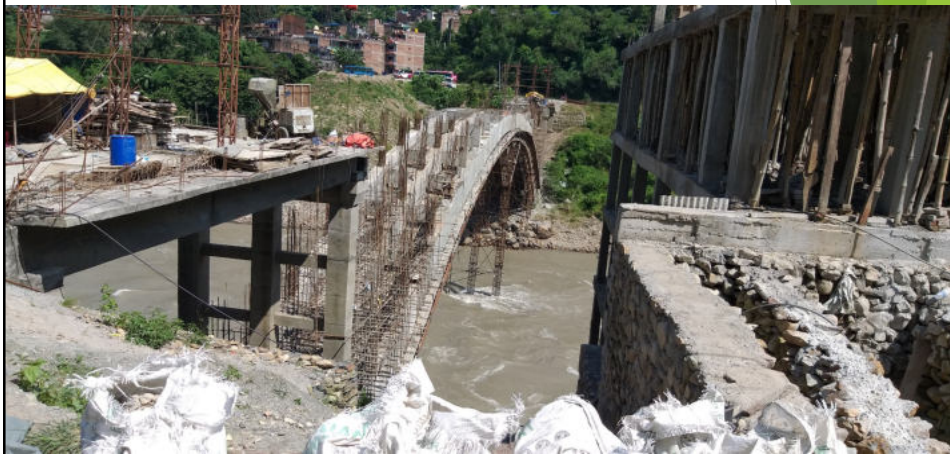
## Trishuli Bridge, Mugling

- ▶ Contract Value NRs 120.8 millions
- ▶ Contract signed on 2069.12.23
- ▶ Original Completion date 2072.12.22
- ▶ EoT granted 3 times, last date for expected completion is 2076.01.31
- ▶ Originally, 120 m length of the bridge was tendered as Design and Build Modality
- ▶ The site could not accommodate the 120 m length
- ▶ Length of bridge is revised as 160 m including 120 m arch as central span and 2x20 m land spans
- ▶ Variation is approved with internal adjustments

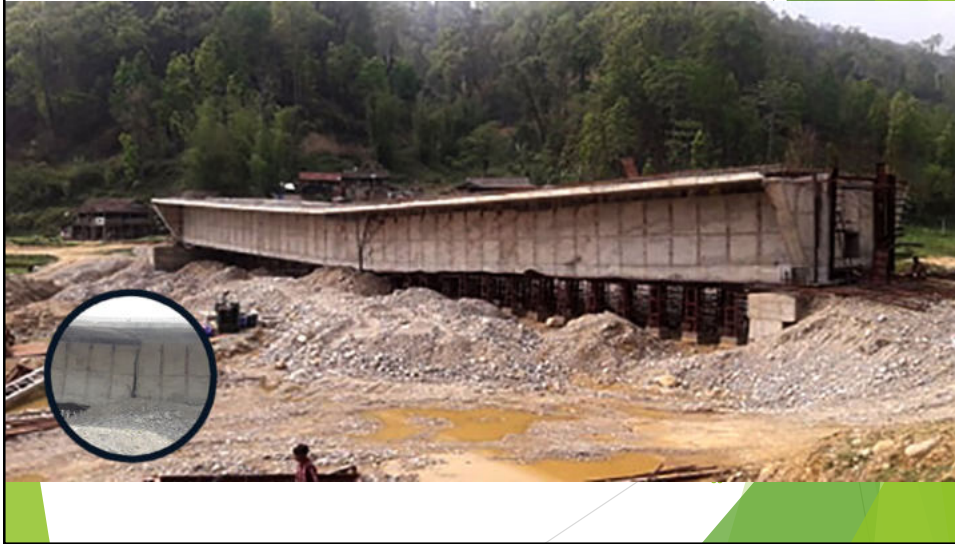
## Thulo Gardwar, Sindhuli

- A Bridge on Hetauda Dharan Road, 32 km west of Sindhuli
- 60 m Span Box Girder
- Concrete was 21 days old
- Tendons were not stretched
- Flood occurred due to heavy storms in 6-7 Chaitra 2075
- Bridge collapsed
- Insurance claimed by the Contractor
- NRs 2.8 Crore
- Time Loss
