Government of Nepal  
Ministry of Physical Infrastructure and Transport  
**DEPARTMENT OF ROADS**

**Guidelines for Inspection and  
Maintenance of Bridges**  
**Vol. 2 - Minor Repairs (Recurrent  
Maintenance)**

**Reprint- 2013**

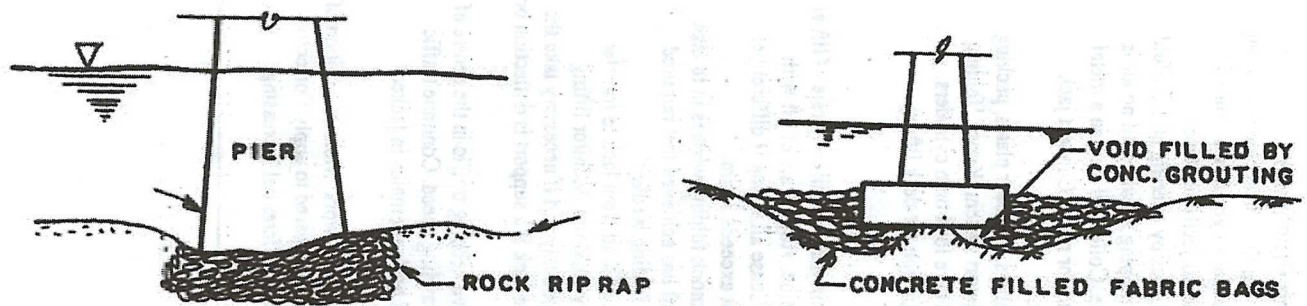
### REMEDIAL WORKS FOR SCOUR AT PIER

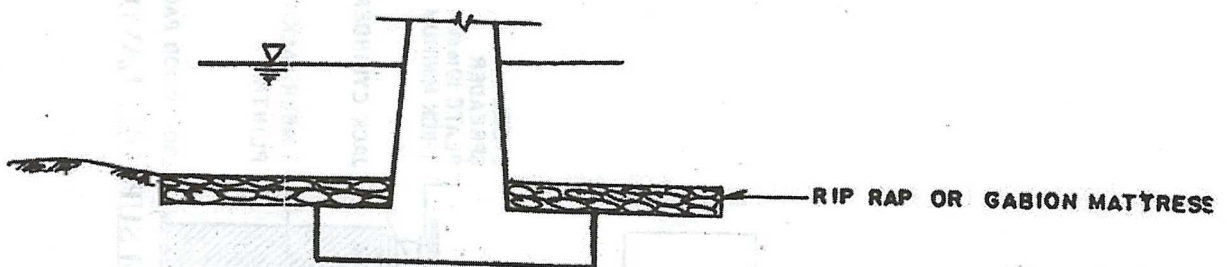
### PROTECTION WORKS AGAINST SCOUR

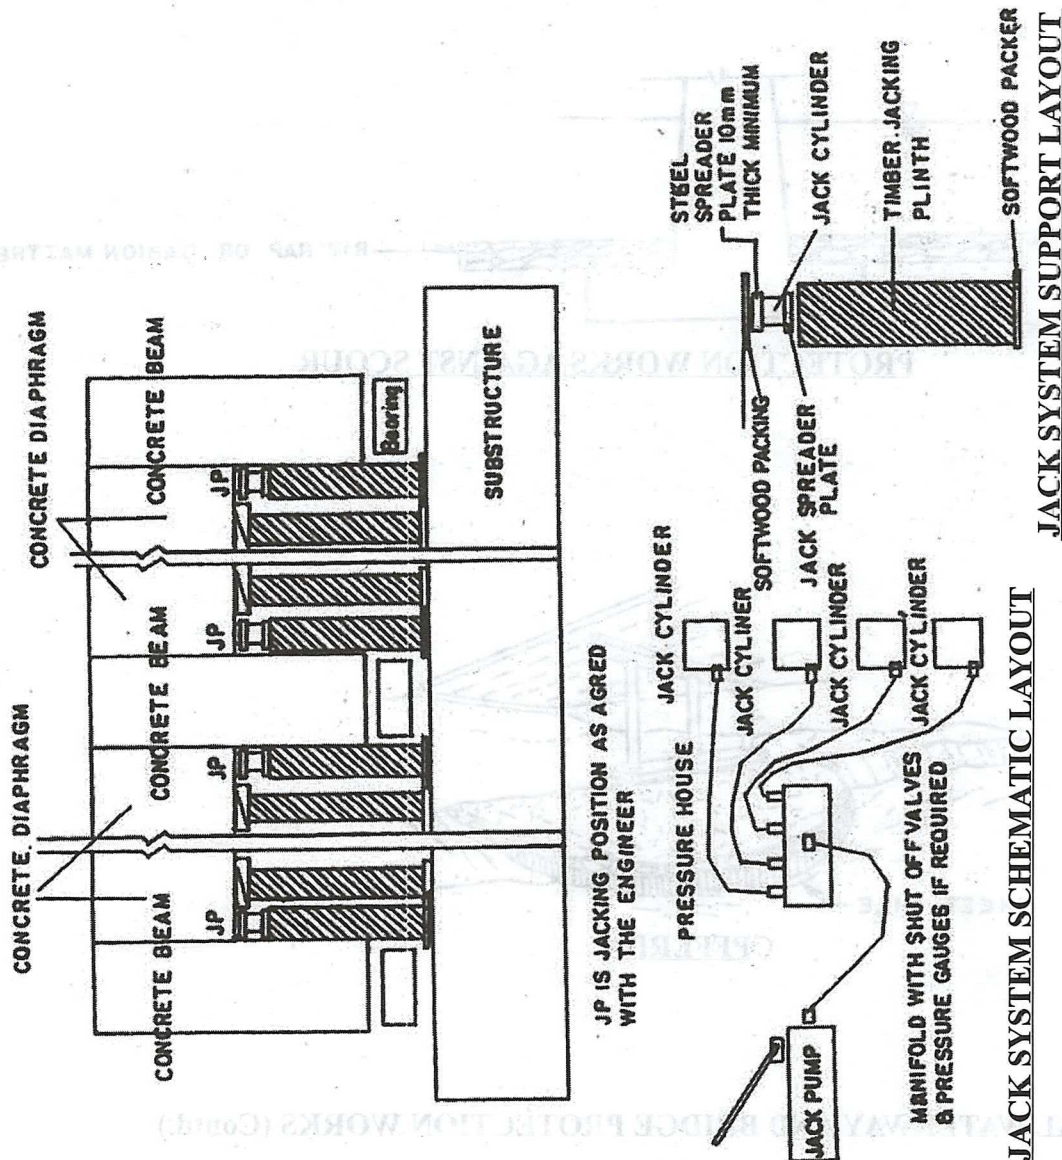
Fig. 2 ARRANGEMENT FOR JACKING UP OF BRIDGE DECK (TYPICAL)

9. Reopen road above keeping traffic in the centre of the road and at crawling speed. Continue traffic control as long as bridge remains in jacked position.

10. Carry out bearing work. Monitor position of Bridge Deck and be prepared to apply Corrective action in case of the differential Increasing.

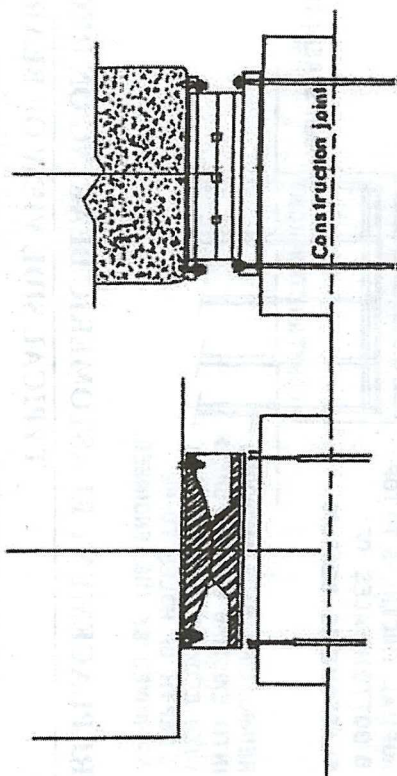
### EXISTING ROCKER BEARING TYPICAL SIDE VIEW

**COMMON MAINTENANCE PROBLEMS:-**  
 TOP & BOTTOM PLATE BODILY RUSTED TO POINT OF  
 DISINTEGRATION  
 ANCHORAGE STUDS & BOLTS RUSTED AWAY BEARING PLINTHS  
 CRACKING, SPILLING & DISINTEGRATING

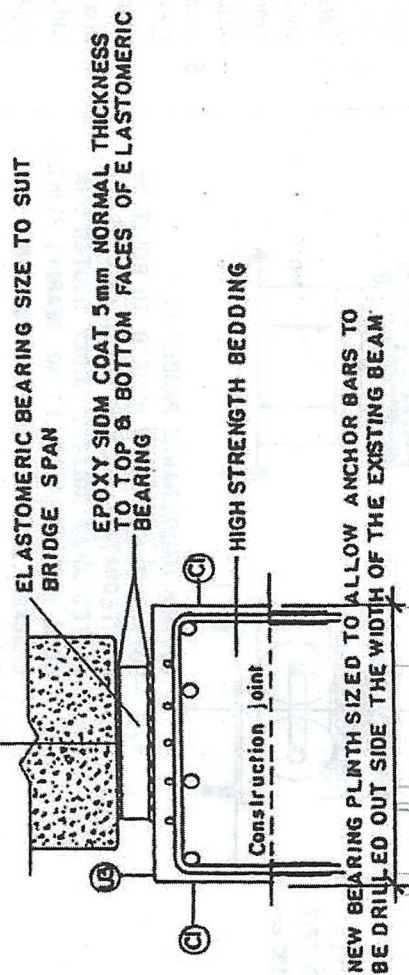
### REPLACEMENT ELASTOMERIC BEARING ON RECONSTRUCTED PLINTH TYPICAL FRONT VIEW OF BEARING

**Fig.6 REPLACEMENT OF ROCKER  
 BEARING WITH ELASTOMERIC  
 BEARING (TYPICAL)**

10. Knock out folding wedges, clean off any debris from bearing shelf and remove equipment.

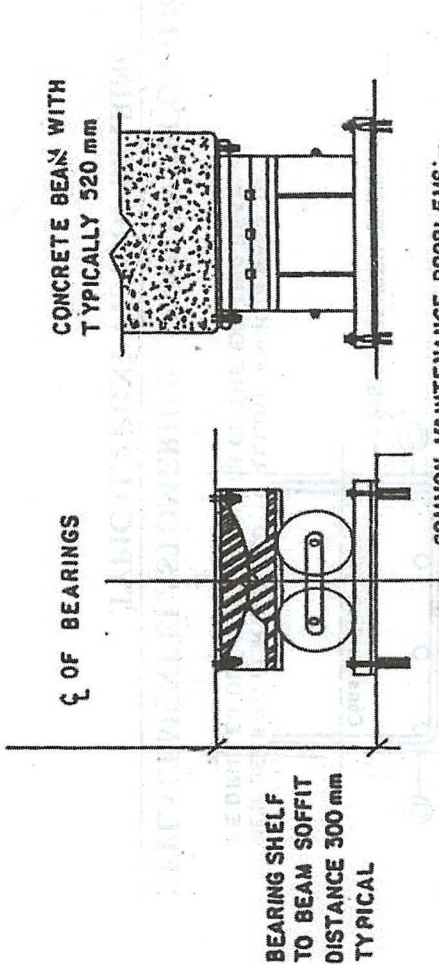
### EXISTING ROLLER CUM ROCKER BEARING TYPICAL SIDE VIEW

**COMMON MAINTENANCE PROBLEMS:-**  
 BOTTOM PLATE BODY RUSTED TO POINT OF DISINTEGRATION ANCHORAGE STUDS & BOLTS RUSTED AWAY ROLLERS BODY RUSTED & IN SOME INSTANCES SPILLING BEARING PLINTHS CRACKING, SPILLING & DISINTEGRATING

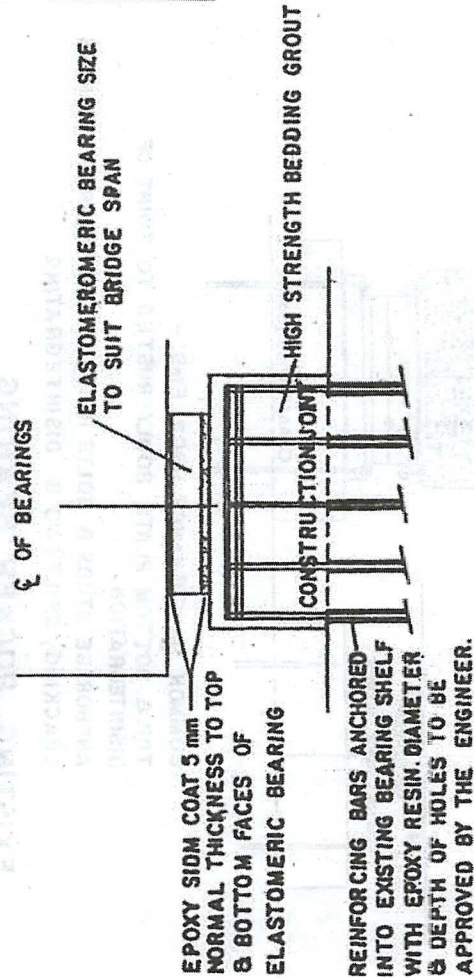
### REPLACEMENT ELASTOMERIC BEARING ON RECONSTRUCTED PLINTH TYPICAL SIDE VIEW OF BEARING

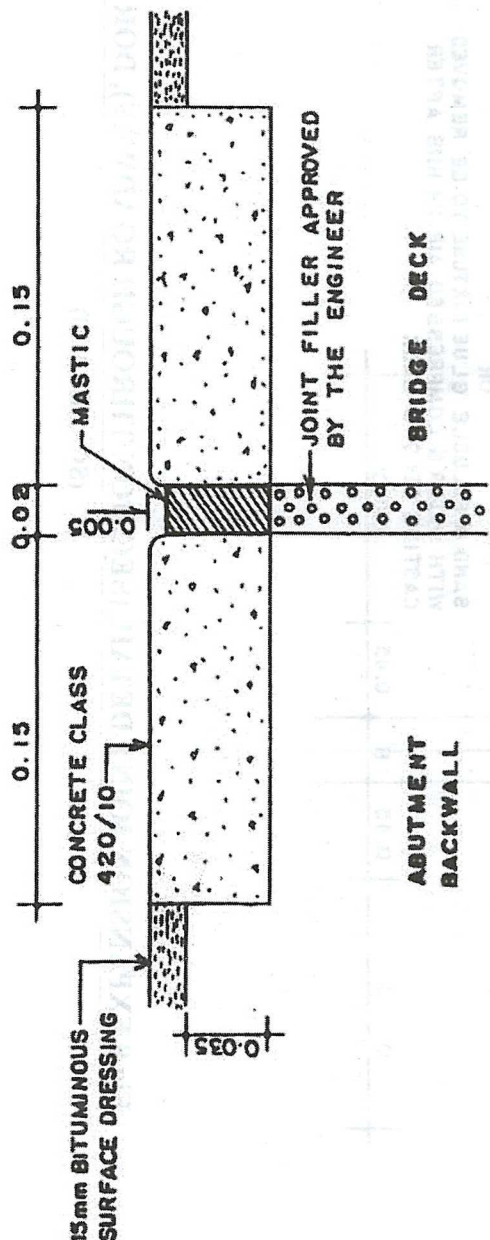
Fig.9a FIXED JOINT DETAIL (SECTION THROUGH ROADWAY), DOR STANDARD DESIGN

RECESSES IN DECK & ABUTMENT TO BE WIRE BRUSHED TO EXPOSE AGGREGATE AFTER CASTING BEFORE CASTING 420/10. CONCRETE OLD CONCRETE SURFACE TO BE RENOVATED DUST FREE THEN PAINTED WITH "WET TO DRY" EPOXY RESIN MIXED AS PER MANUFACTURES INSTRUCTIONS 420/10 CONCRETE TO BE CAST IN 1.50 M. LENGTHS WITH ONE LAYER BITUMINOUS ROOFING FELT BETWEEN EACH LENGTH 2. JOINTS ON EXPANSION & FIXED JOINTS TO BE CAST USING DESIGNED MIX, ORDINARY CONCRETE CLASS 420/10.

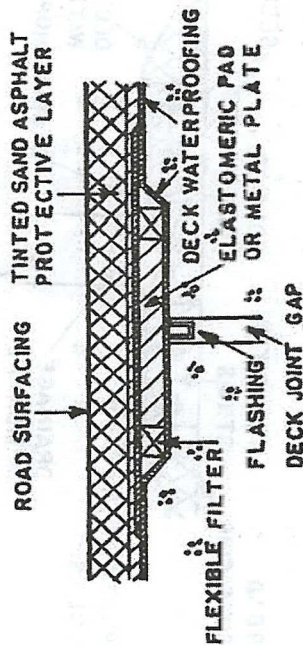
### Buried

One or more components may be used to form continuity of the waterproofing and surfacing. These can comprise or proprietary flashings and straps with bridging plates or similar. Movement ranges generally  $\pm 10$  mm maximum.

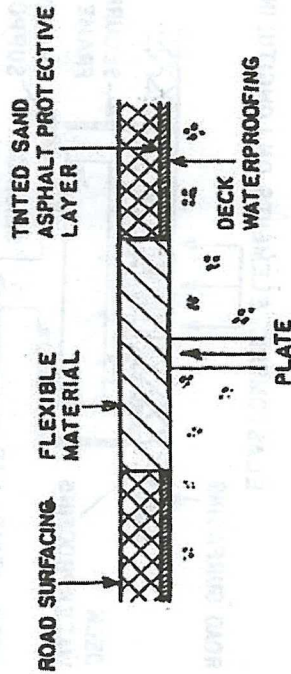
### Asphaltic Plug

Proprietary systems comprising of layers of specially modified binders and aggregate to provide a homogeneous expansion medium and smooth running surface. Movement ranges of standard grade modified binders up to  $\pm 20$  mm.

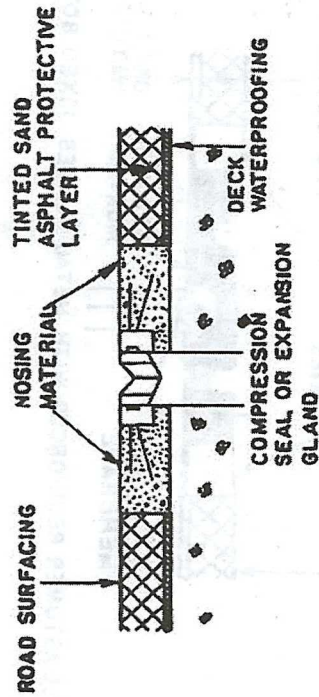
Nosings/Elastomeric elements in metal runners  
Insitu modified resin nosing material bonded to the deck, incorporating steel rails or angles with cellular neoprene insert or similar which is mechanically retained or bonded to the metal rails. Movement ranges generally up to  $\pm 50$  mm.

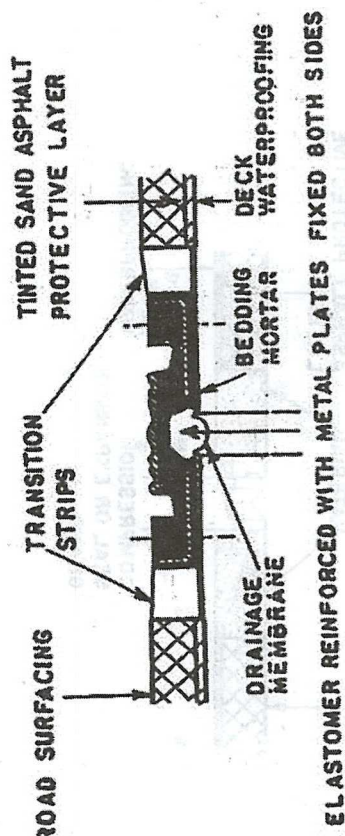
### Elastomeric

Elastomeric segmental joints comprising neoprene rubber with reinforcing angles and plates bolted down to structure on top of a drainage membrane with epoxy bedding and transition mortars. Movement ranges generally  $\pm 25$  mm to  $\pm 165$  mm.

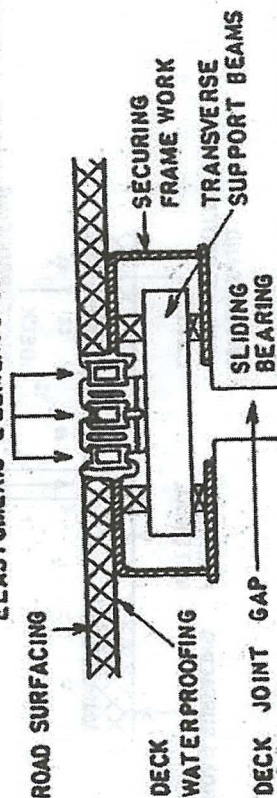
### Elastomeric elements in metal runners

Single or multiple elastomeric elements supported on metal supports which are cast into box outs within the bridge structure. Movement ranges generally  $\pm 480$  mm.

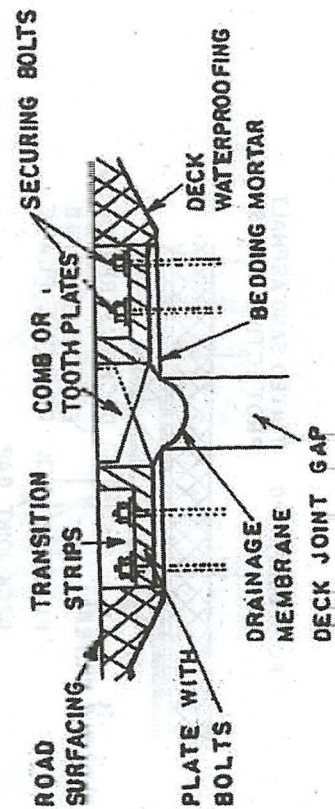
### Cantilever comb or tooth joints

Cantilever comb or toothed metal plates mated together and bolted to each side of the bridge joint with a drainage membrane. These can be proprietary systems or made specifically to suit the bridge movement and construction. Movement ranges generally up to  $\pm 300$ mm.

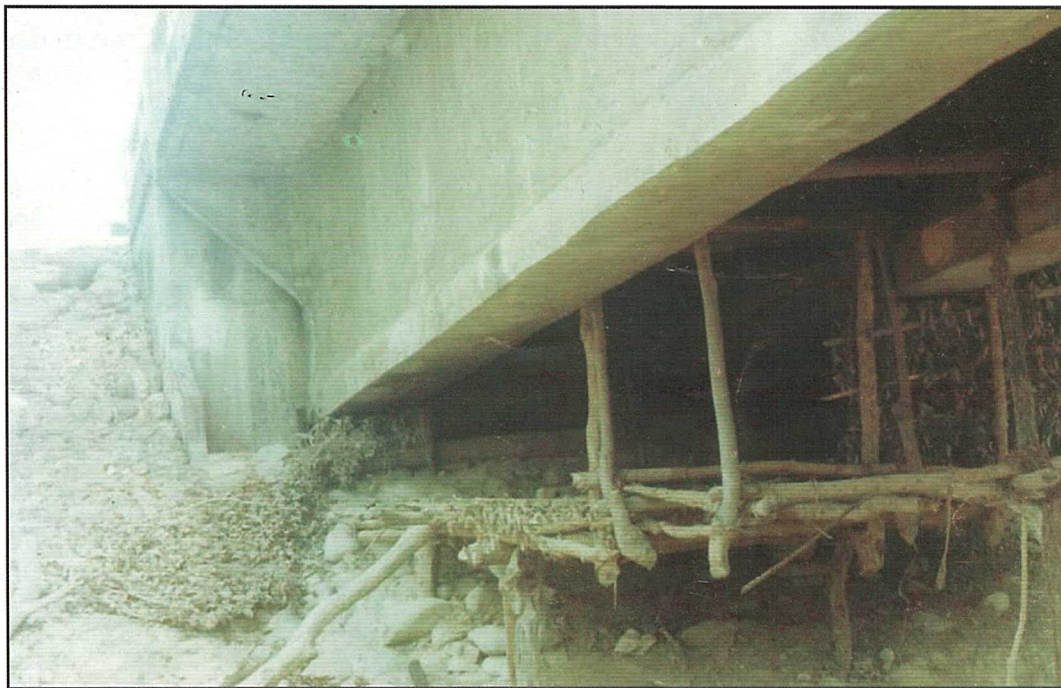
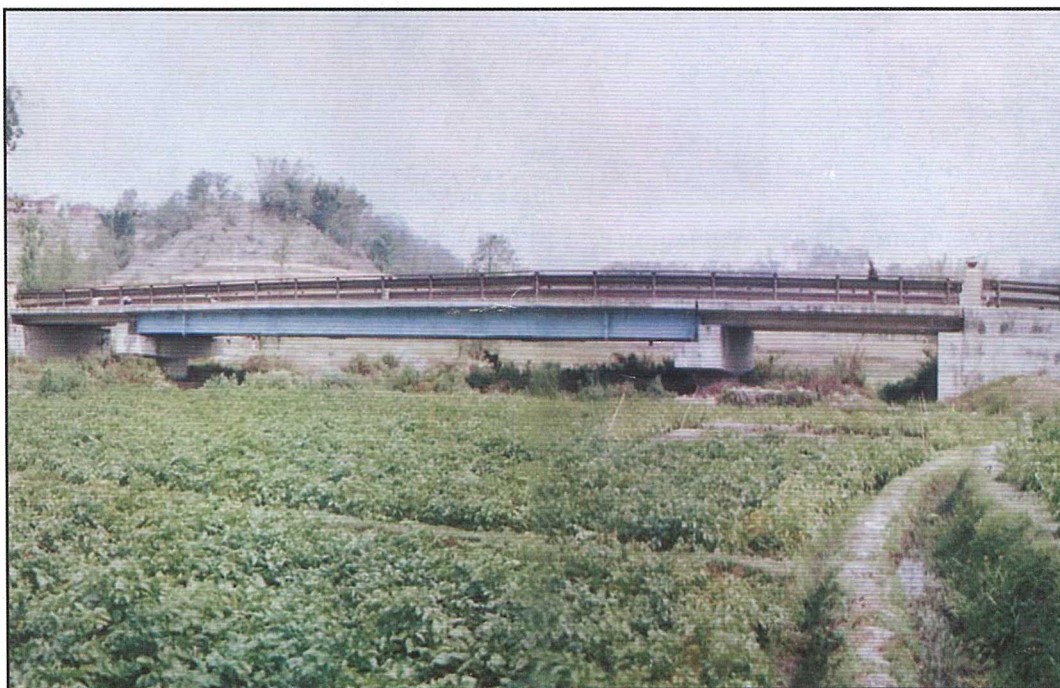
**1-2 Blocked Waterway Needs clearing off**

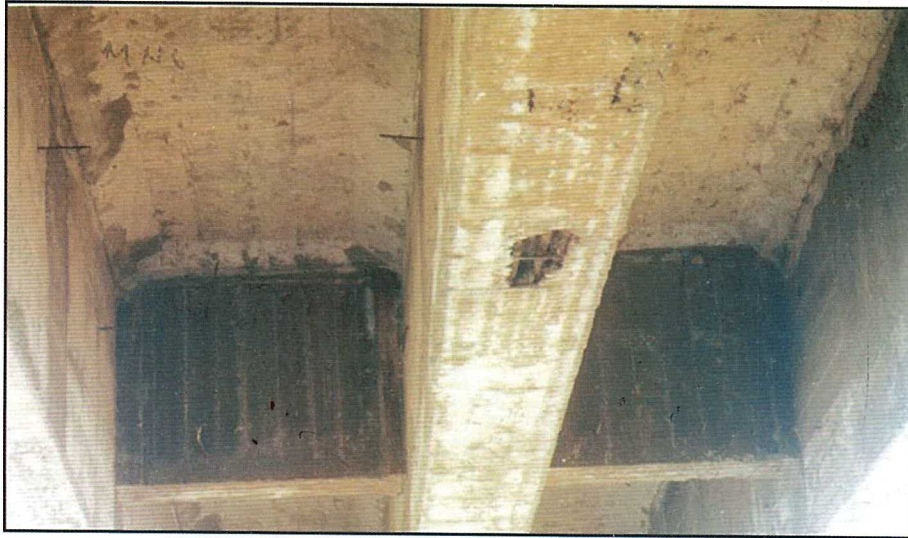
**3- Honey Combs and Exposed Reinforcement on Main beams**

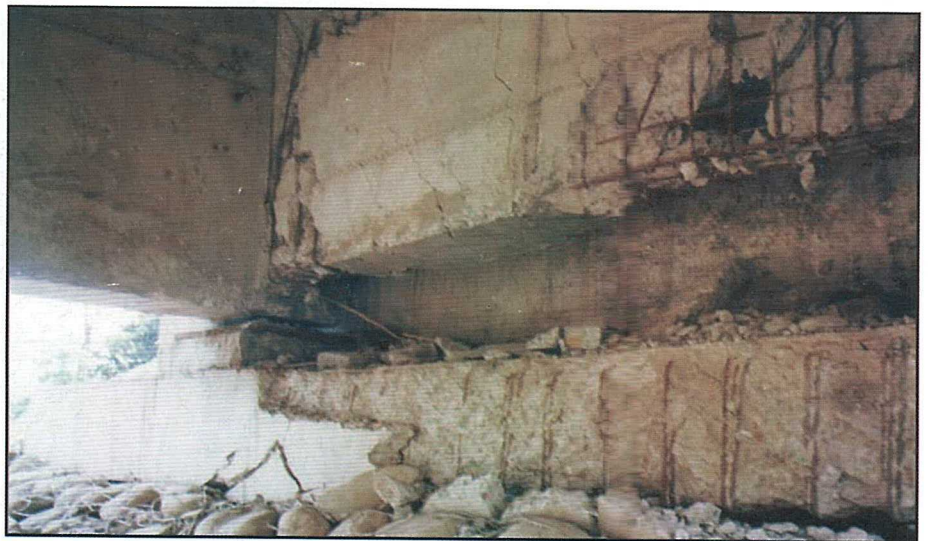
**4- Crushed cross Beams and abutment Head**

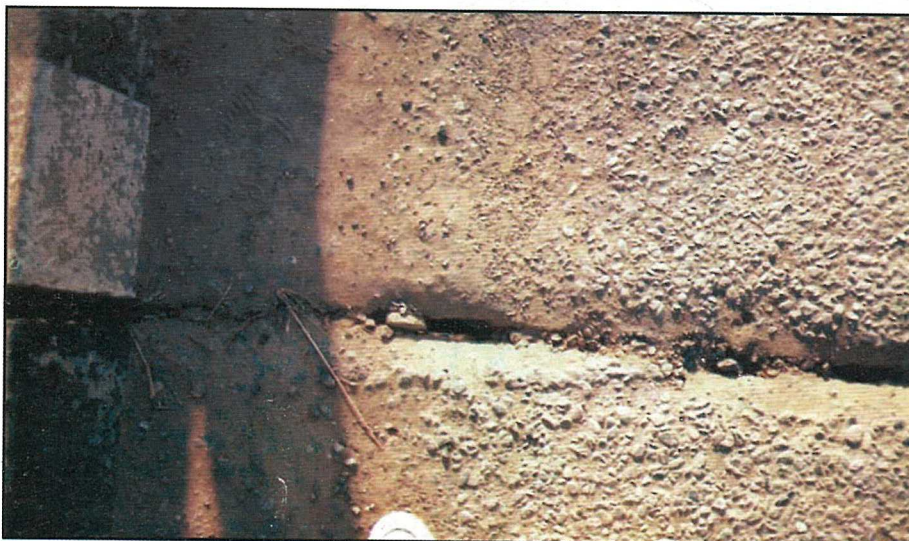
**5- Expansion joint needs to be cleaned off to allow joint movement**

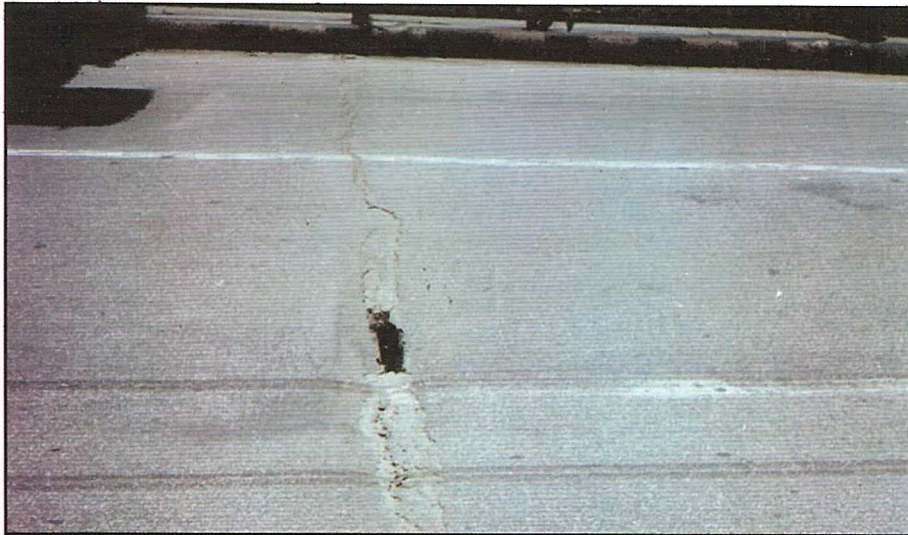
**6- Missing angle plated and compression seal on Expansion joint**

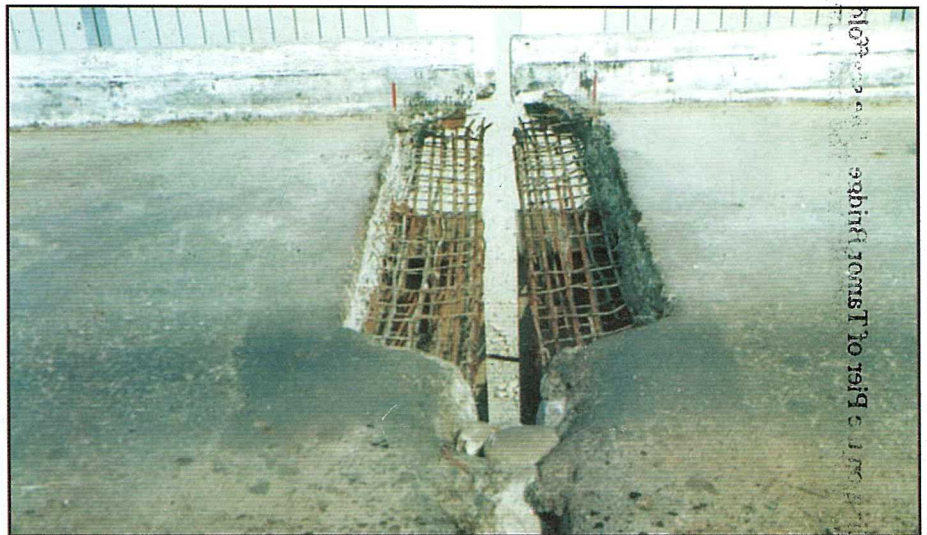
**7- Replacement of Expansion joint (Working half widths)**

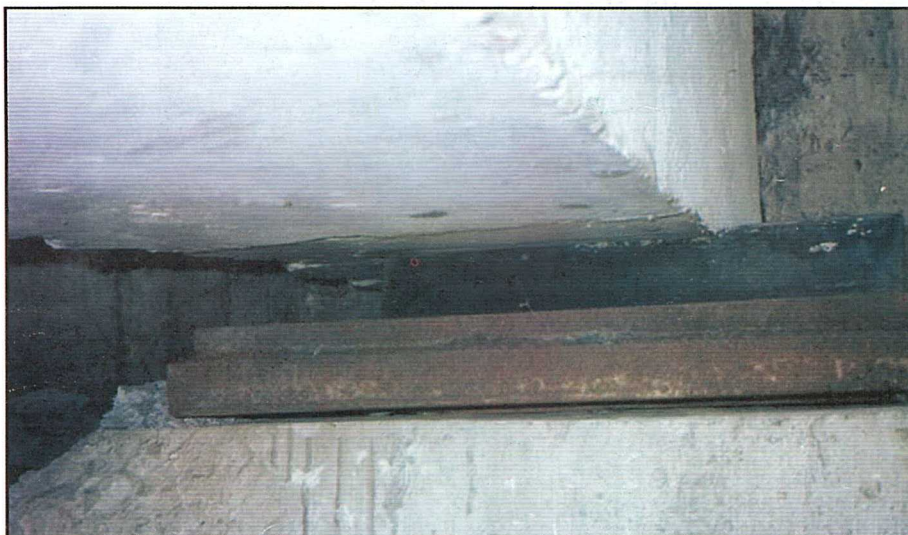
**8- Elastomeric Bearing slipped off, needs repositioning**

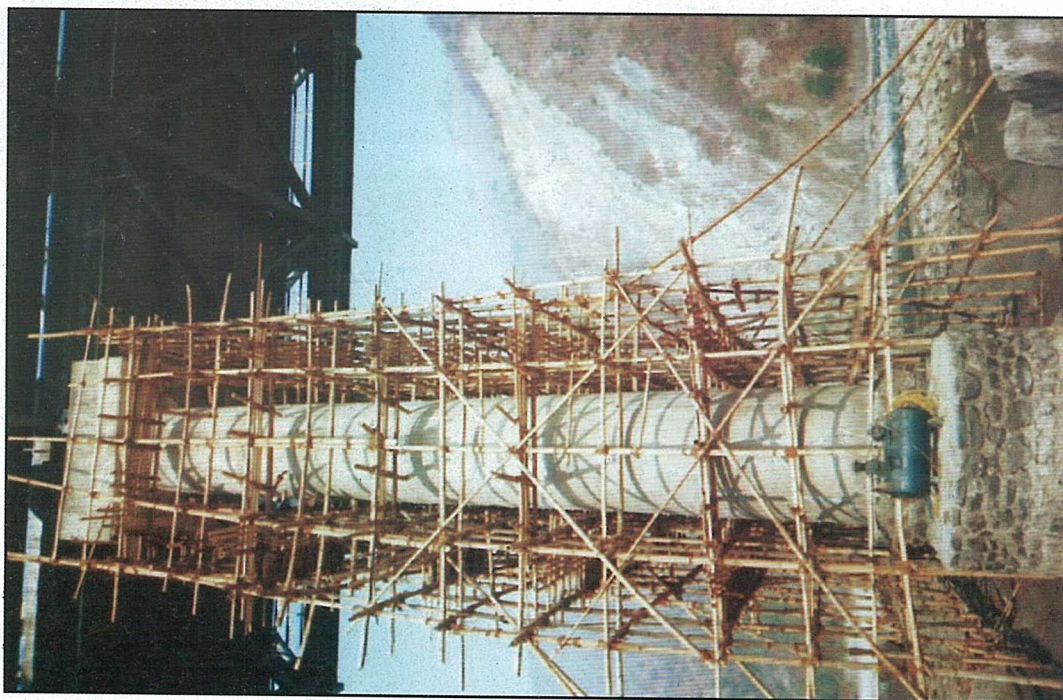
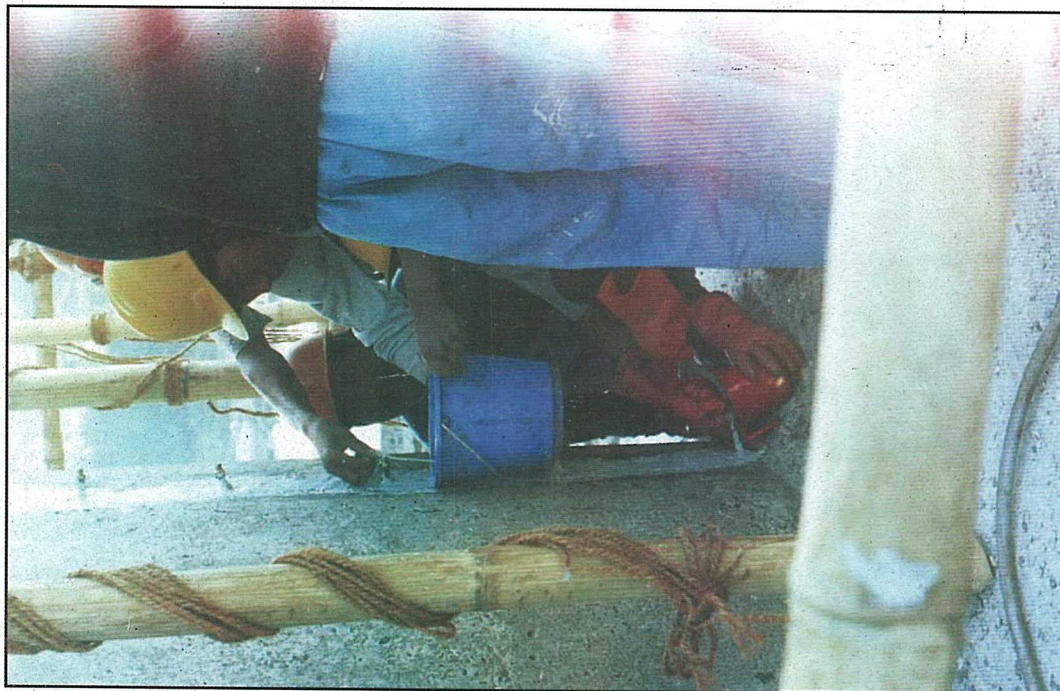
Photo 9: Crack Sealing on the Pier of Tamor Bridge : The scaffolding and sealing work

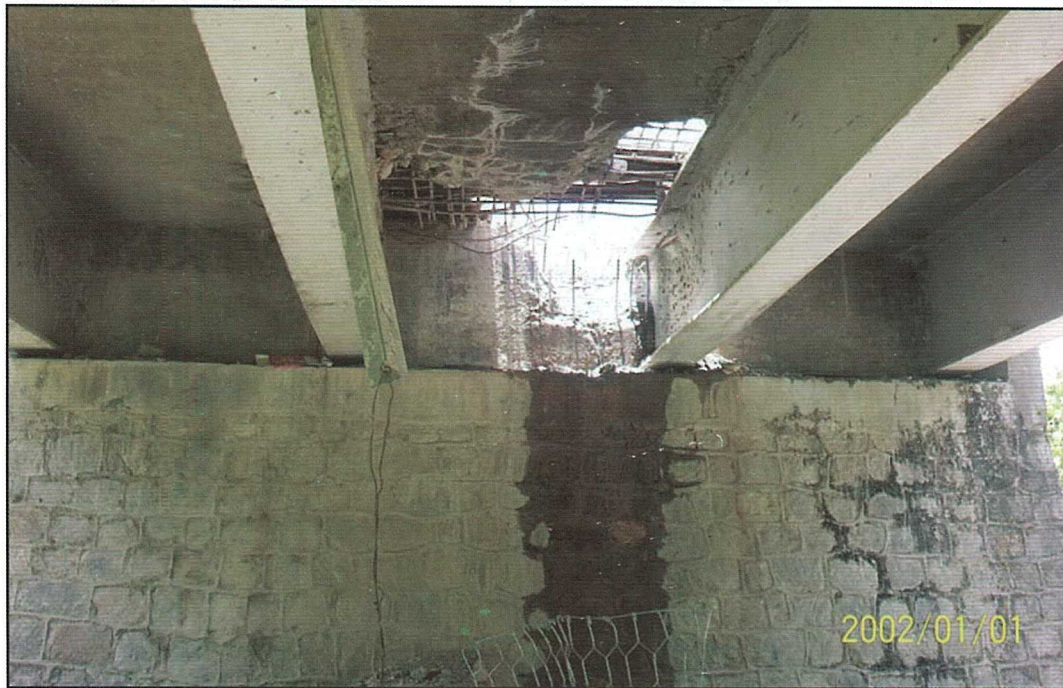
**The damaged plate girders**

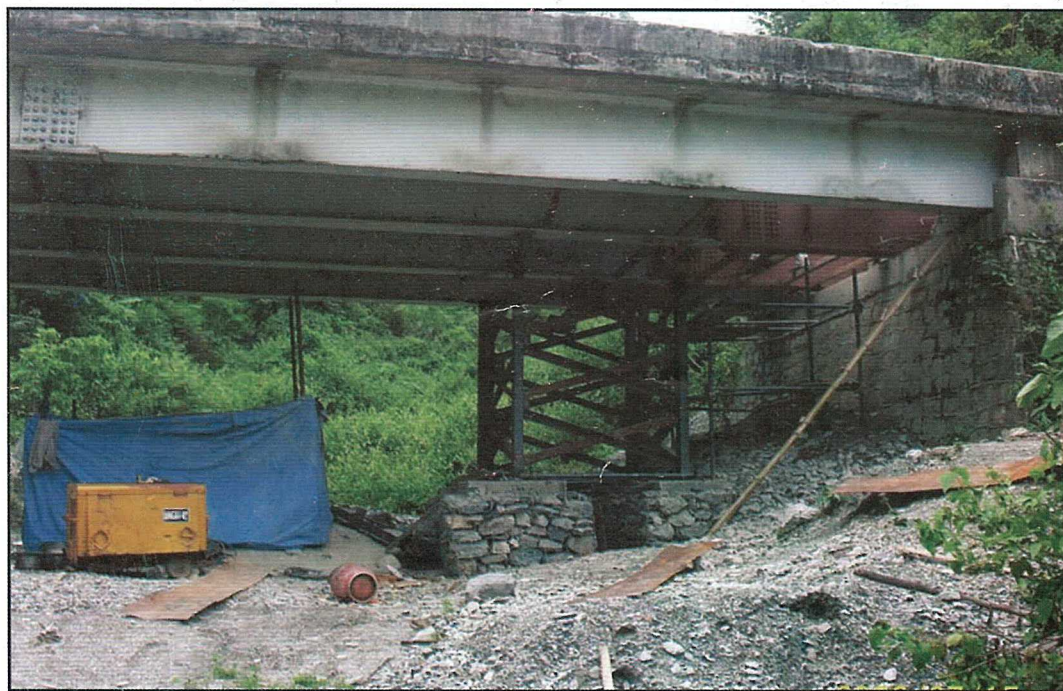
**Staging for repair works**

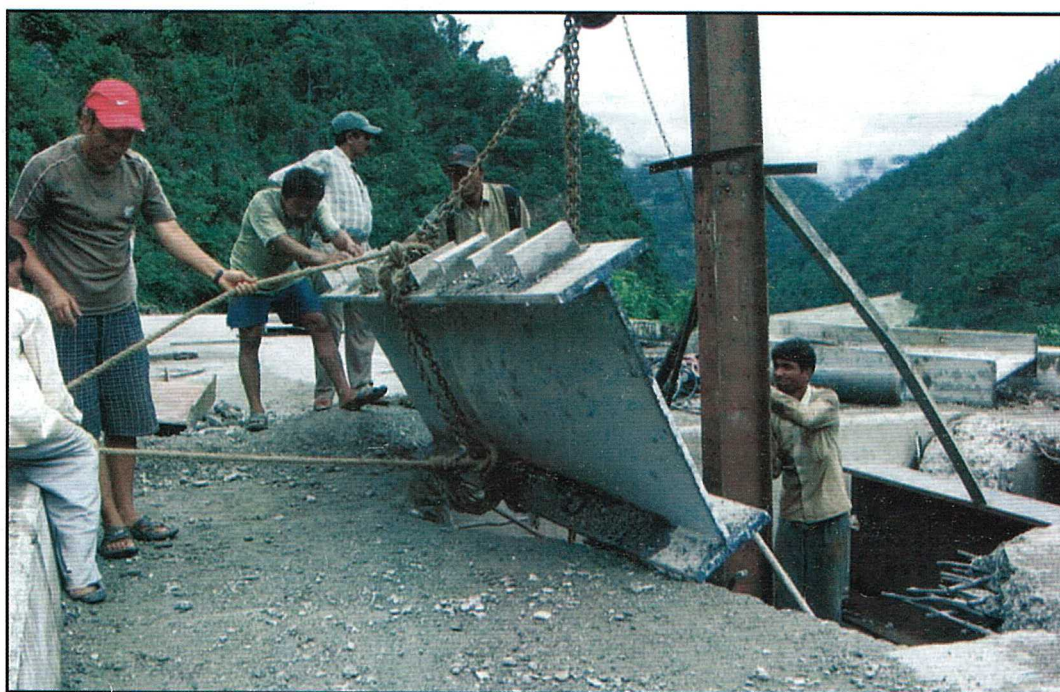
**Removal of damaged girder section**

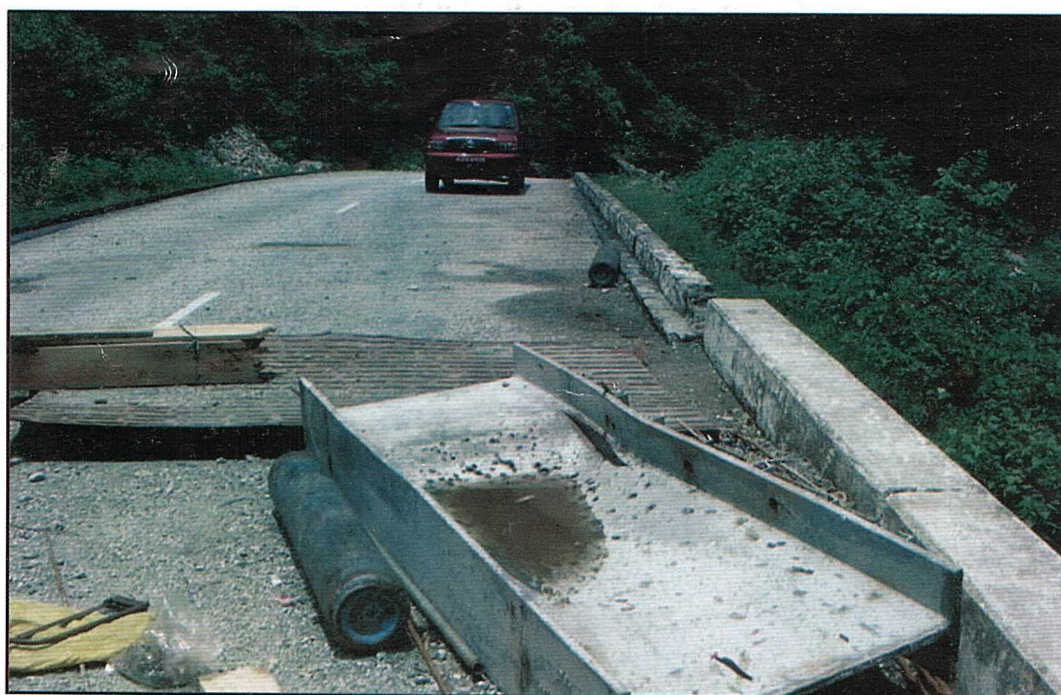
**The removed damaged girder section**

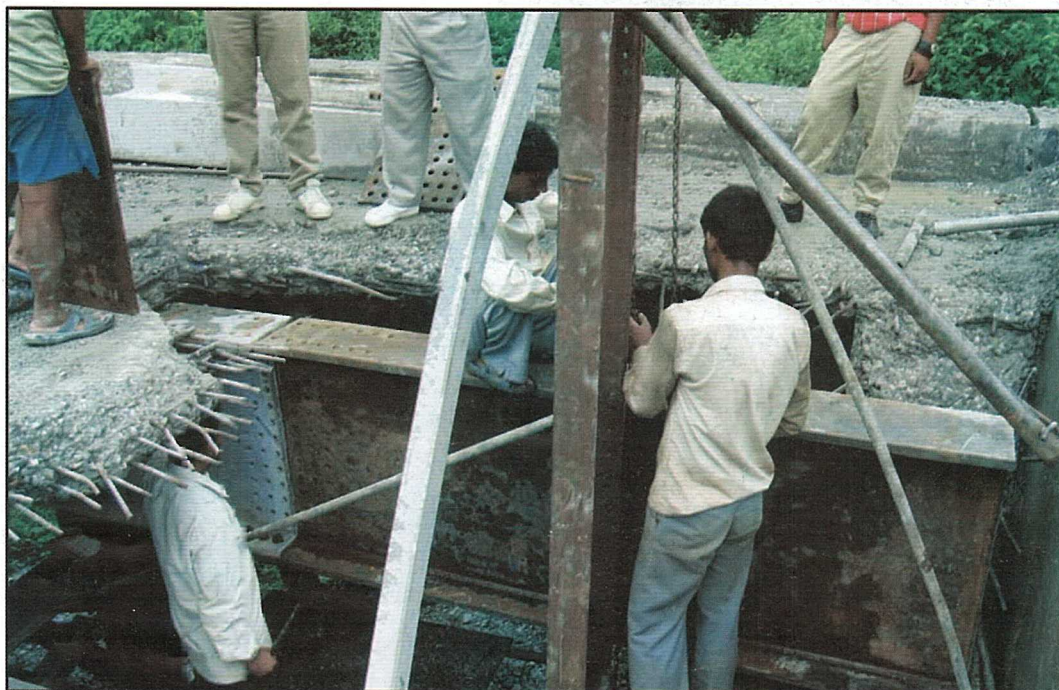
**Lowering and Position of new girder section**

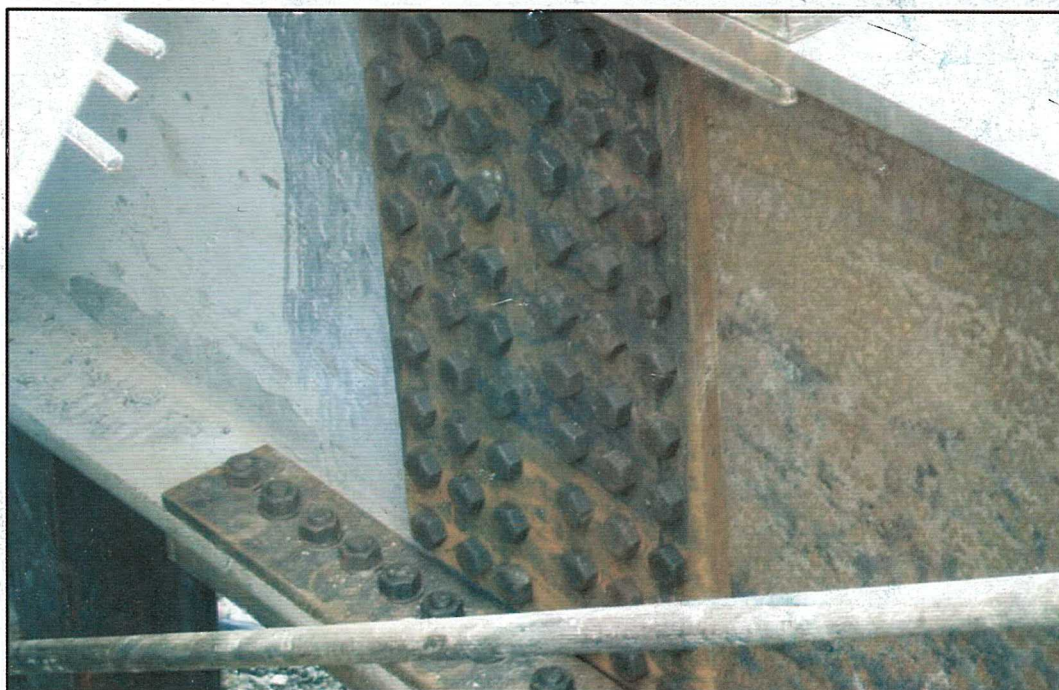
**Fixing the new girder section with old girder**

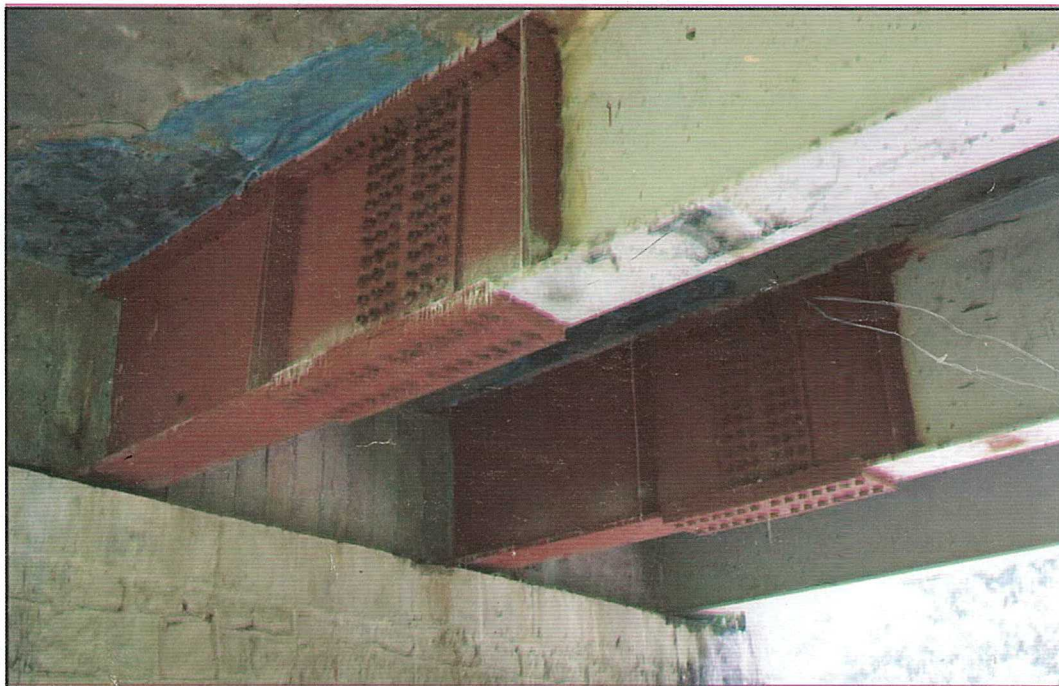
Two out of three girders are repaired

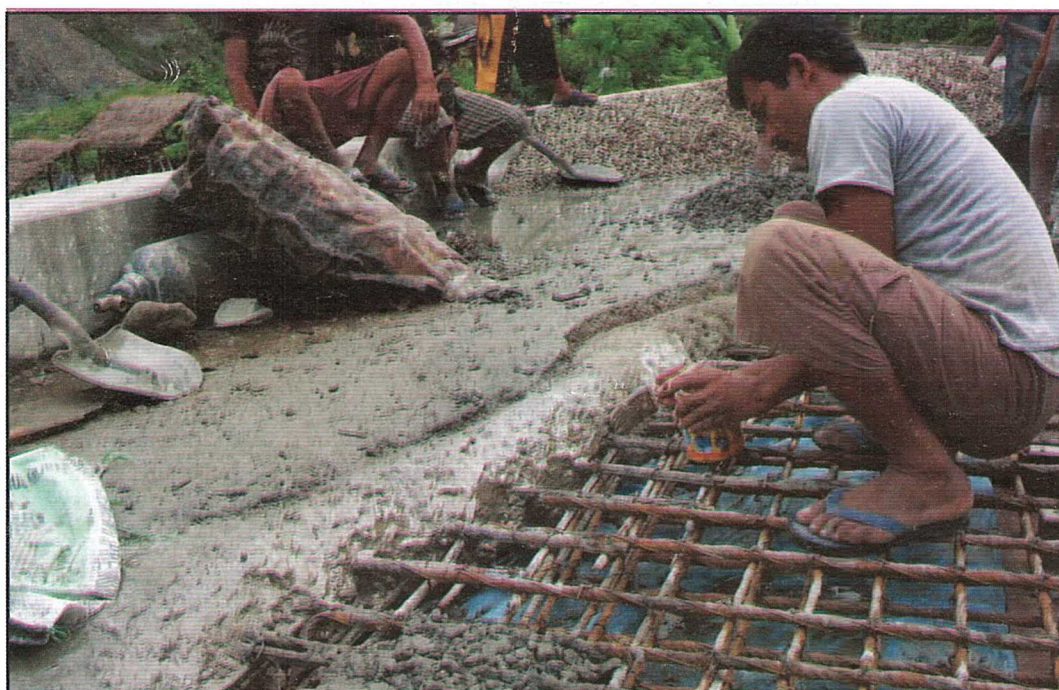
Fixing of reinforcement and concreting
